conservation plan

MARR HOTEL

1.1 History/Description of the Marr Hotel (Secord Hotel), 401 Powell Street

3.1 Condition Assessment

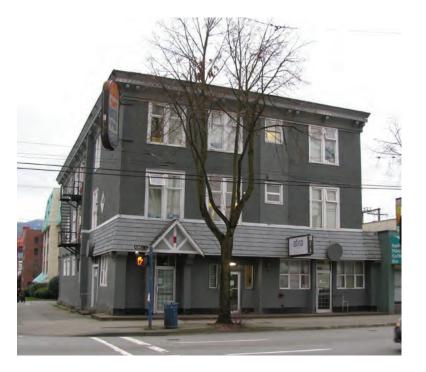
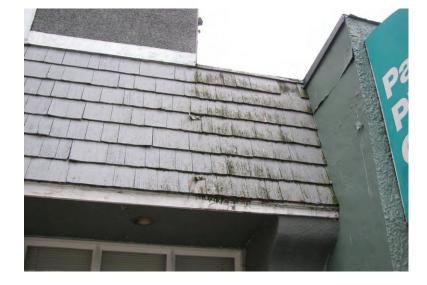
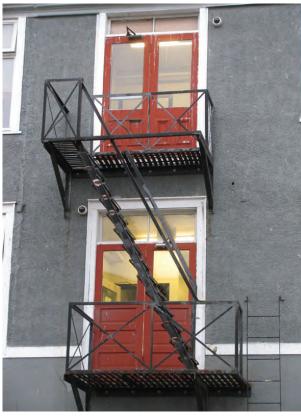
Marr Hotel at the corrner of Powell Street & Dunlevy Avenue- Exterior photo survey, 2011

Condition Assessment Marr Hotel (Secord Hotel)		
Element	Description/Condition	Image Reference
Stucco facade cladding	The stucco cladding has spalled and cracked in a number of isolated areas.

Condition Assessment Marr Hotel (Secord Hotel)		
Element	Description/Condition	Image Reference
Wooden & Sheet Metal Cornice	The wooden cornice elements are in fairly good condition, with select brackets missing. The top portion of the cornice (most likely sheet metal) is missing/boarded over. The end bracket at the east corner on Powell Street is missing and the cornice is exposed and vulnerable to weather ailments and debris collection.

Condition Assessment Marr Hotel (Secord Hotel)		
Element	Description/Condition	Image Reference
Storefront	The original storefront with chamfered corner entry has been replaced with an inappropriate substitute and lacks the original heritage character. The barge board on the gabled massing over the front entry has deteriorated and the cedar shake shingles are showing evidence of mold growth and will require select replacement.	Image Reference

Condition Assessment Marr Hotel (Secord Hotel)		
Element	Description/Condition	Image Reference
Element Upper Façade Windows	The original double hung wood windows on the upper façade of both street elevations have recently been replaced with aluminum fixed/awning windows.	Image Reference

Condition Assessment Marr Hotel (Secord Hotel)		
Element	Description/Condition	Image Reference
Brick Chimney	The existing brick chimney at the rear (NE corner) needs to be repointed and cleaned.

Condition Assessment Marr Hotel (Secord Hotel)		
Element	Description/Condition	Image Reference
Rear Exit Stair	The rear exit stair was a recent addition, and appears to be in good condition and code compliant.	
Fire Escape	The existing fire escape requires an upgrade.

The stucco cladding is showing signs of minor deterioration in areas of high water runoff. It will be patch repaired as necessary on all facades.

The upper sheet metal and wood cornice has deteriorated in select areas and select brackets are missing. The upper portion of the cornice has been removed and/or boarded over. There will be sectional replacement and patching as required. This condition cannot be fully ascertained until full scaffold access is provided and paint stripping initiated, but sectional replacement of brackets and rusting horizontal surfaces is to be anticipated. The sheet metal cornice cap will need to be removed and replaced to allow seismic tie-back/upgrading of the cornice support structure.

The inappropriate and insensitive storefront alterations over the years (including removal of the chamfered corner entrance) have resulted in a significant loss of heritage character and value. A full restoration of the original storefront is not proposed at this time. Minor repairs will be done to extend the life of the existing storefront, including the replacement of the deteriorated bargeboard on the gabled massing over the front entry and select replacement of the cedar shake shingles.

The existing brick chimney will be removed.

The existing fire escape on Dunlevy will be upgraded.

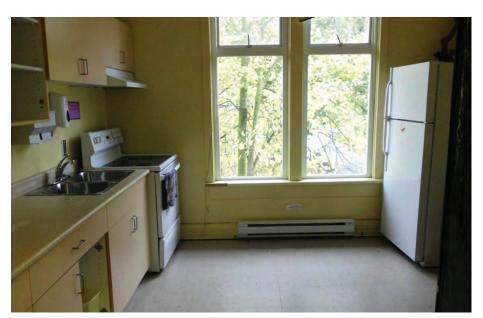
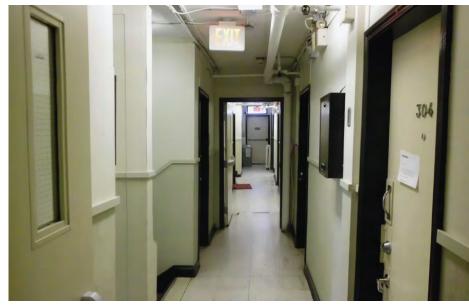
Marr Hotel at the corrner of Powell Street & Dunlevy Avenue- Interior photo survey, 2011

Condition Assessment Marr Hotel (Secord Hotel)		
Description/Condition	Image Reference	
The existing two ply SBS roof surface is fairly new and appears to be in good condition.		
The original reinforced concrete foundation wall, timber beams and columns supporting the exterior wall, & post and beam framing on the upper floors have all survived in generally good condition.		
Little of the interior character of the building has survived the many interior renovations. Original window casings in the south kitchen will be retained.		
	Description/Condition The existing two ply SBS roof surface is fairly new and appears to be in good condition. The original reinforced concrete foundation wall, timber beams and columns supporting the exterior wall, & post and beam framing on the upper floors have all survived in generally good condition. Little of the interior character of the building has survived the many interior renovations. Original window casings in the south kitchen will be

Original interior window casings will be preserved.

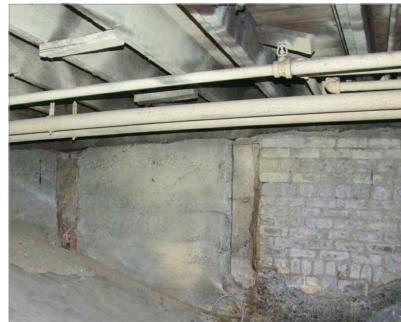
EXISTING FOUNDATION WALL DETAIL

2. SOME EXISTING EMBEDDED FOUNDATION WALL POSTS HAVE BEEN CHANGED OUT TO TREATED 6"x6" POSTS AS RECENT REPAIRS.
