conservation plan

RICE BLOCK

404 HAWKS AVENUE, VANCOUVER, BC

McGinn Engineering & Preservation Ltd./
BARRY MCGINN ARCHITECT

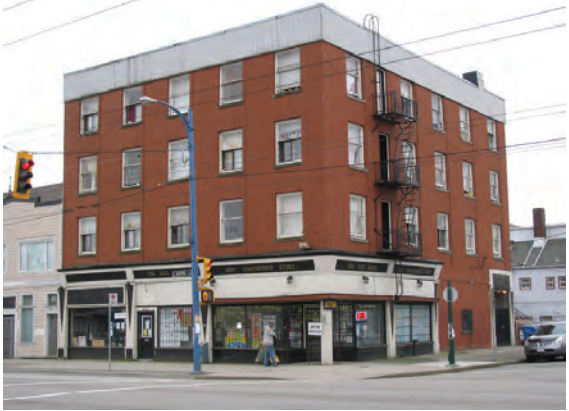
Condition Assessment Rice Block (Thistle Rooms)		
Element	Description/Condition	Image Reference
Form, Scale and Massing	No significant alterations or additions have affected the building's form scale and massing and these aspects of the building are essentially original. The east light court will be retained and currently also serves the tenants as an outdoor courtyard.

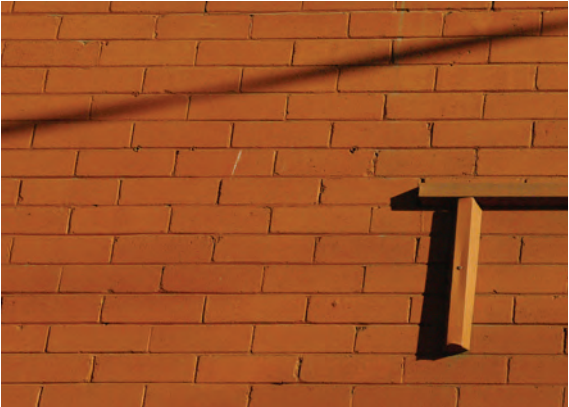
Condition Assessment Rice Block (Thistle Rooms)		
Element	Description/Condition	Image Reference
Street Façade Masonry	The original dark beige face brick is in poor to fair condition, and has been painted. Mortar joint deterioration and loss is evident in many areas and there are several attachment holes in the brick.

The existing dark beige brick masonry will be restored through paint stripping and full repointing, minor patching for attachment holes and spalls, and cleaning. The rock-faced granite storefront pier bases will be repointed and cleaned. Most of the shelf angle lintels supporting the Hastings Street elevation will be removed and replaced with new hot dip galvanized shelf angles, and cracked and broken face bricks replaced.

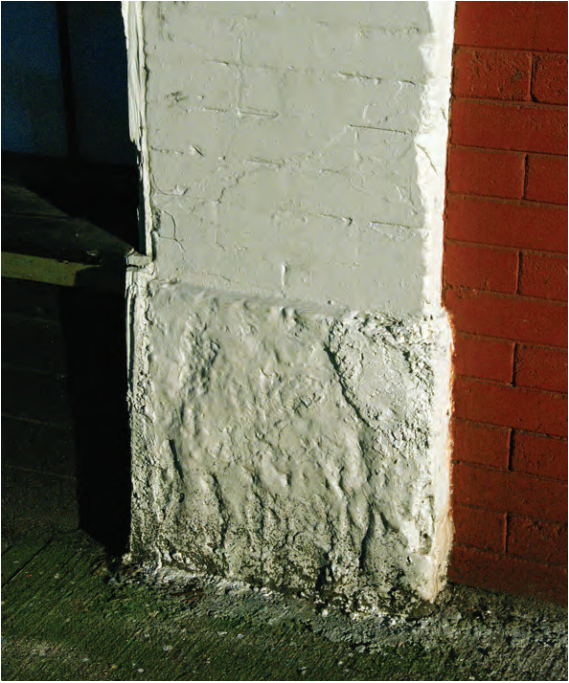
The veneer brick is showing signs of distress and displacement on the Hastings Street façade due to the corrosion of shelf angles at window openings. The shelf angle is rust-jacking the brick veneer, and possibly back brick, resulting in spalling above the shelf angle, diagonal shear cracking and some veneer wythe displacement at a couple of locations.

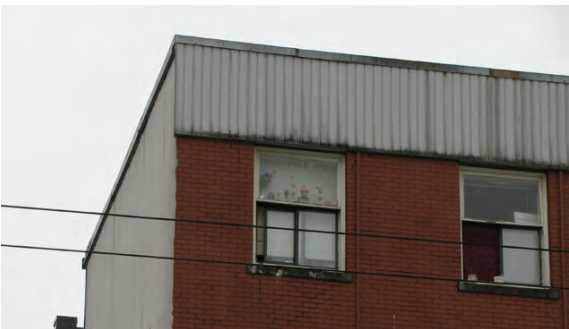
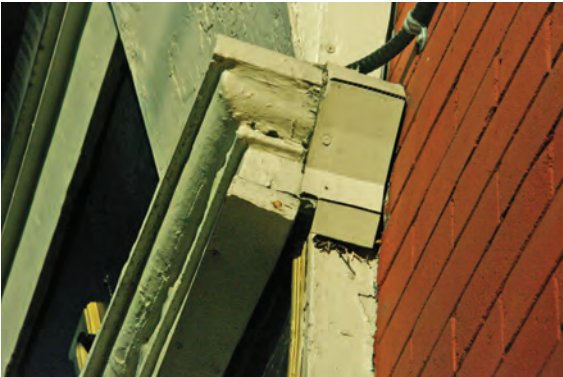
Condition Assessment Rice Block (Thistle Rooms)		
Element	Description/Condition	Image Reference
Sheet Metal	The original bracketed sheet metal upper cornice has been removed, and a sheet metal cladding installed in its place. Portions of the storefront cornice may have survived behind the current wood cladding. The original pier capital moldings have survived in a couple of locations. A 1960s image provides a glimpse of the original storefront cornice at the east end of the Hastings Street façade. A 1940s image shows the original upper sheet metal cornice, which projected a fair distance, but was relatively shallow, allowing for a brick parapet at Hastings Street.

The original storefront sheet metal cornice likely exists in a deteriorated condition beneath the existing wood cladding and coverings. Although quite typical of the period, the bracket features at each storefront pier impart a quiet beauty and order to the storefront. Due to the nature of sheet metal cornice corrosion, little of this original cornice is likely reusable, but it can serve as a reliable model for this cornice restoration. The current restoration design drawings are based on a 1960s historic photograph, and may be subject to minor revisions once the actual surviving cornice (if it has survived) is examined in detail. A good example of the original sheet metal pier capitals has survived and will be suitable as a model for restoration of this element.

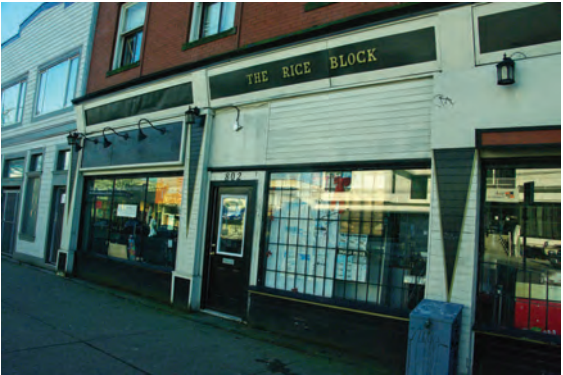
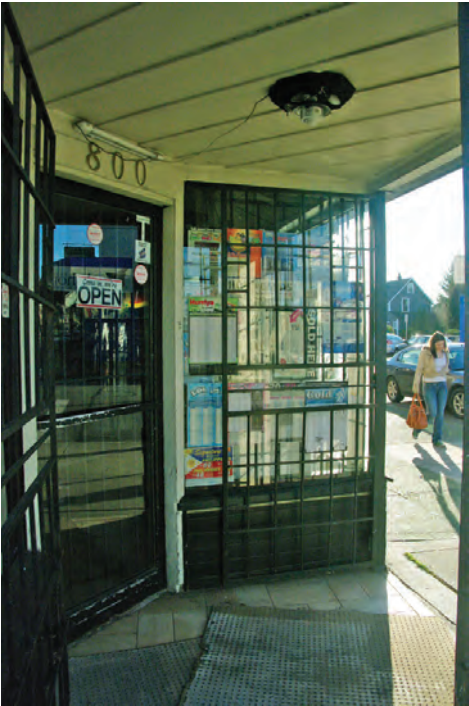
Condition Assessment Rice Block (Thistle Rooms)		
Element	Description/Condition	Image Reference
Storefront	<p>The original storefront appears to have largely survived behind an array of low quality wood cladding systems. This has preserved the original storefront configuration, with its distinctive chamfered open corner entry, featuring a diagonally positioned entry door.</p> <p>The base was likely brick, but is clad in T&G siding, as are most of the brick piers which clad steel columns supporting the storefront lintel beam. Some of the storefront piers have simply been painted.</p> <p>The original lower storefront window frames, with their robust molded profiles, have survived, although there may be some deterioration beneath the current sill cladding boards. The condition of the clearstorey windows is unknown, as they are clad on both the interior and exterior. The clearstorey sill has survived and is evident. It is likely that the storefront window frames are in place, but the sash have deteriorated or been removed.</p> <p>Assumptions will be made about surviving heritage fabric and conditions, which can be confirmed once the exterior and interior cladding is removed, allowing inspection.</p>

A significant upgrade for this building will be to restore the storefront, which has been inappropriately altered over the years. Originally, twinned lintel beams over all of the storefront areas, allowed for a highly glazed corner storefront on Hastings Street and a portion of Hawks Avenue. A unique aspect of this storefront was the generously chamfered corner entry at Hawks Avenue and Hastings Street. The original

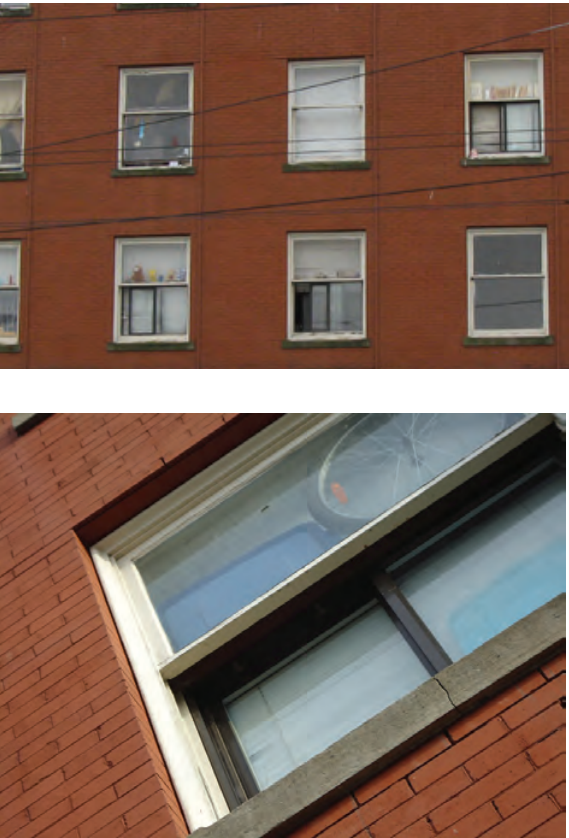
Condition Assessment Rice Block (Thistle Rooms)		
Element	Description/Condition	Image Reference
Upper Front Façade Windows	Many of the original wood double hung, single glazed windows have survived, but most of the sashes have reached the end of their service life, and most of the rope and pulley assemblies are not operational. A number of wood sash have been replaced with aluminum fixed/slider window inserts. The original wood frames are in fair condition, but require refurbishing with some sill re-surfacing required. The original brick moldings are still in place, and in reasonable condition.

need of some rehabilitation, specifically sill resurfacing or selective replacement on the north elevation, and selective jamb and brick mold scarf joint patches on the north façade. The surviving wood single glazed sashes have reached the end of their service life. They, and any aluminum window inserts, will be replaced with new double glazed double hung wood sash. The weights will be changed out to heavier weights for the heavier sash, pulleys replaced or reconditioned, and cords replaced. Metal, tamper-proof stops will be set in the jamb frames to limit the upper and lower sash to a maximum of 4" of opening. The windows will be prepared and painted.

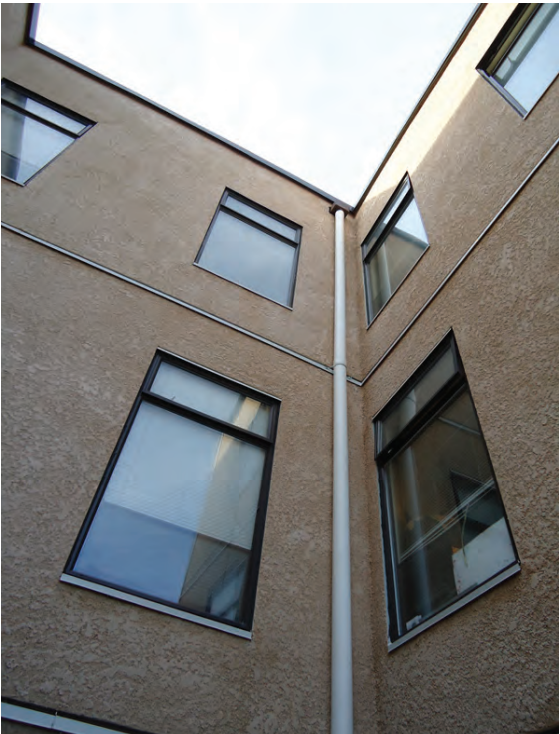
Condition Assessment Rice Block (Thistle Rooms)		
Element	Description/Condition	Image Reference
East Light Court Windows	The original pressed metal light court window frames have been replaced with new aluminum windows on the east light court.

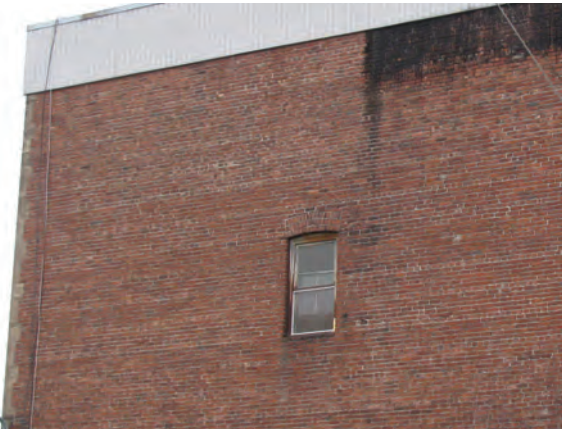
Condition Assessment Rice Block (Thistle Rooms)		
Element	Description/Condition	Image Reference
Rear Window	The single original rear façade pressed metal double hung window has survived, but it is very rusted and at the end of its service life. The pressed metal frame extends to the brick face; there is no brick molding.

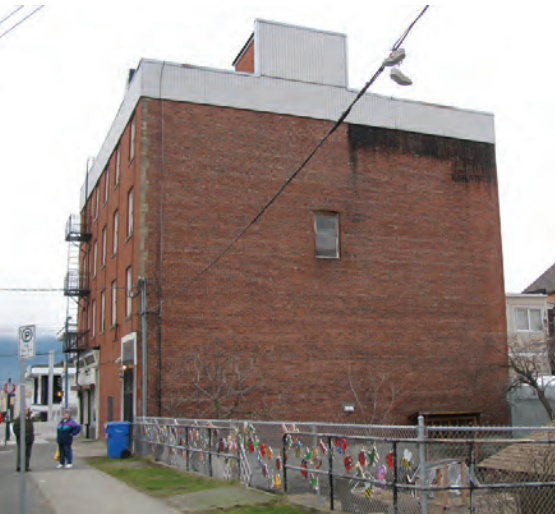
Rear Façade Masonry	The rear façade red back-brick masonry has not been painted, but has been repointed with a harder mortar than appropriate. Nevertheless, apart from liquid tar staining at the upper east corner, it is in good condition.

The rear brick façade will be selectively repointed and the liquid tar stains removed at the upper east corner.

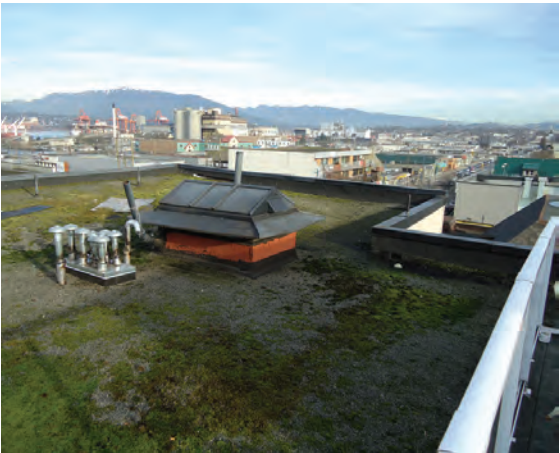
Condition Assessment Rice Block (Thistle Rooms)		
Element	Description/Condition	Image Reference
Roof Surfaces	The roof surface sits on a light wood frame and roof board construction, built to slope to scupper drains at the light court. The current SBS roof surface is fairly new, as are the parapet cap flashings and scupper drains. The light court roof surface leaks and requires replacement.

The existing two ply SBS roof surface has been in place a few years, and likely has another eight to ten years of service life remaining. However, the envelope seismic stabilization structural upgrade of the brick parapets will damage the perimeter and the light well wall, and it will be cost effective to replace this roof surface. New enamelled galvanized parapet cap flashings and scupper drains will be installed.

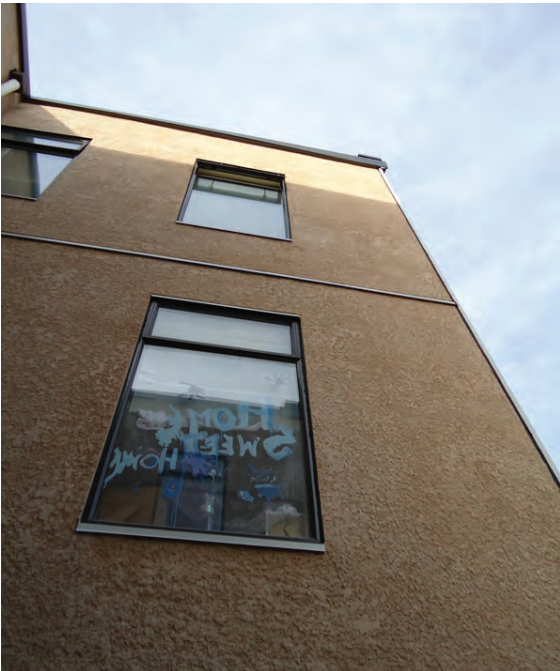
Light Court Wall	The east light court wall has been replaced fairly recently with a new rainscreen stucco system with through wall flashings, and appears to be functioning well.

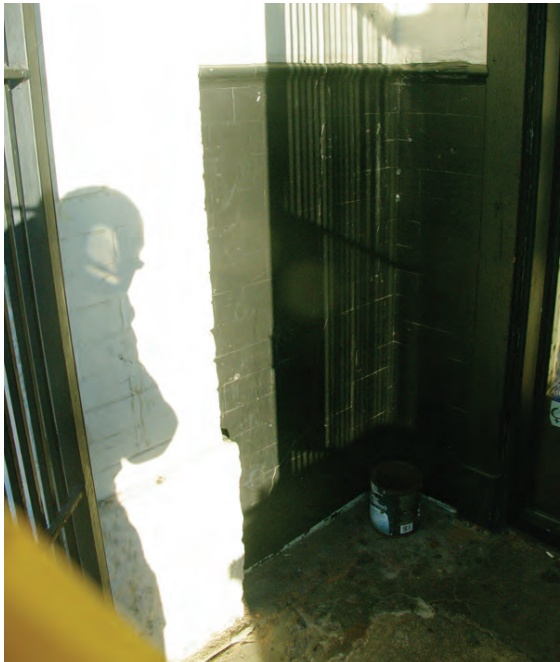
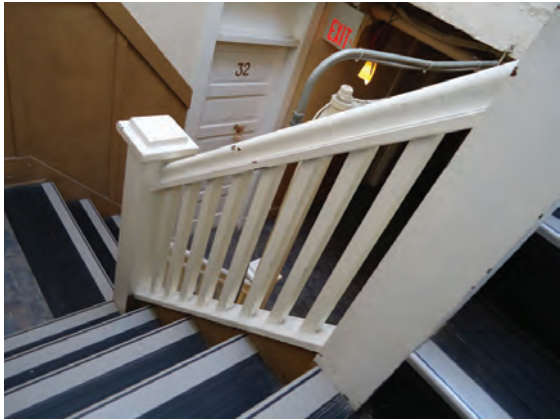
Condition Assessment Rice Block (Thistle Rooms)		
Element	Description/Condition	Image Reference
Interior Features	The glazed subway tile hotel entry wainscot has survived at the hotel entry. The wood balustrade of the interior stair is in good condition and quite handsome, and it has survived.

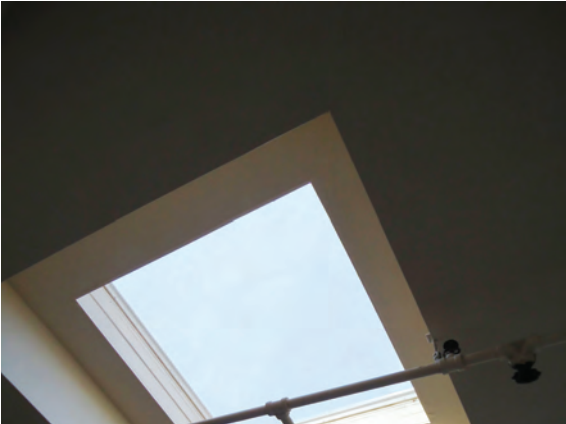
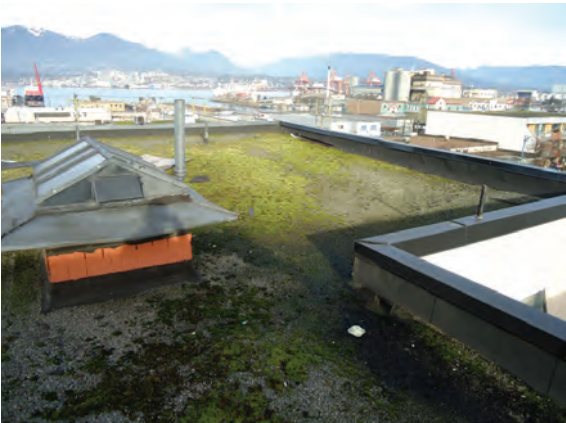
Condition Assessment Rice Block (Thistle Rooms)		
Element	Description/Condition	Image Reference
Skylights	The skylight over the open stair is in good condition and appears to be functioning well. The ventilator skylight that was originally mounted on the internal ventilation/light shaft will need to be re-instated.

Ensure the existing original skylight/ventilator shaft is upgraded to the required FRR and the roof top features of these shafts remain water proof and weather tight. Remove any original windows opening onto these shafts as required to achieve the FRR.

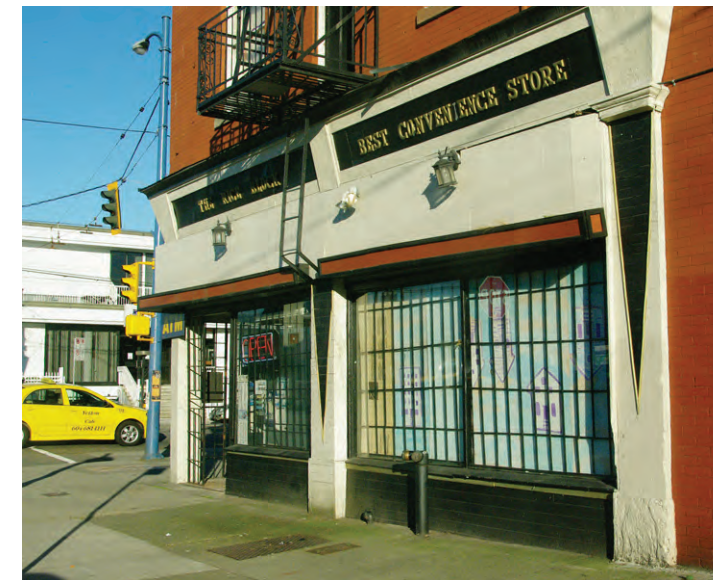
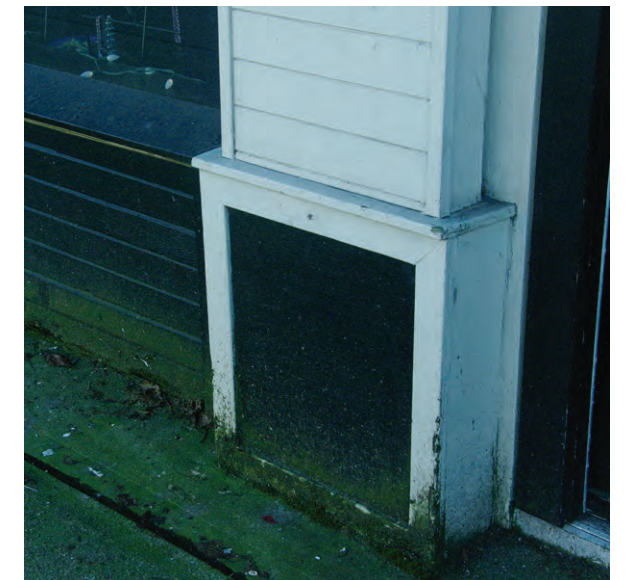
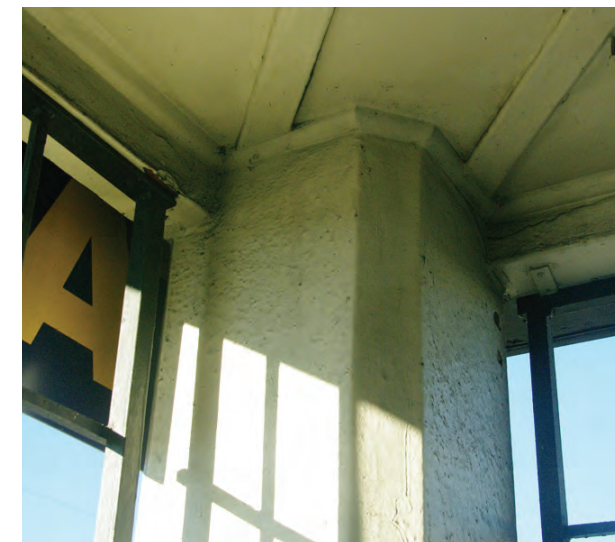
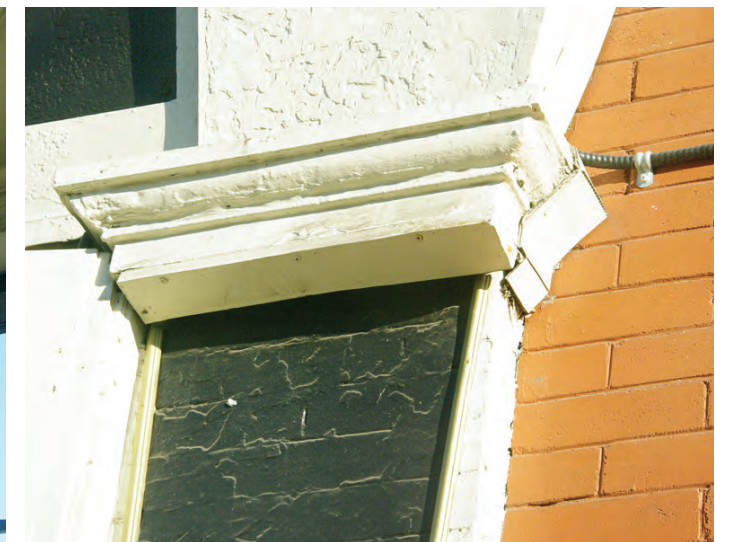
Existing storefront details at the Rice Block,
Vancouver, 2012

Although concealed by much wood cladding and board covers, it would appear that much of the original storefront is in place, although the concealed clearstorey window framing and sash may be in poor condition.

brick or tile storefront base is in its original location, but has been cladded over. The original fixed lower storefront windows still have their robustly molded exterior stops, painted many times over. The clearstorey has been clad on the inside and out, so the condition of the clearstorey framing and sash are not known. The 1960's image provides a good image of the Hastings Street storefront, showing the mullioned lower fixed sash, and the clearstorey, with its multiple sashes per bay.

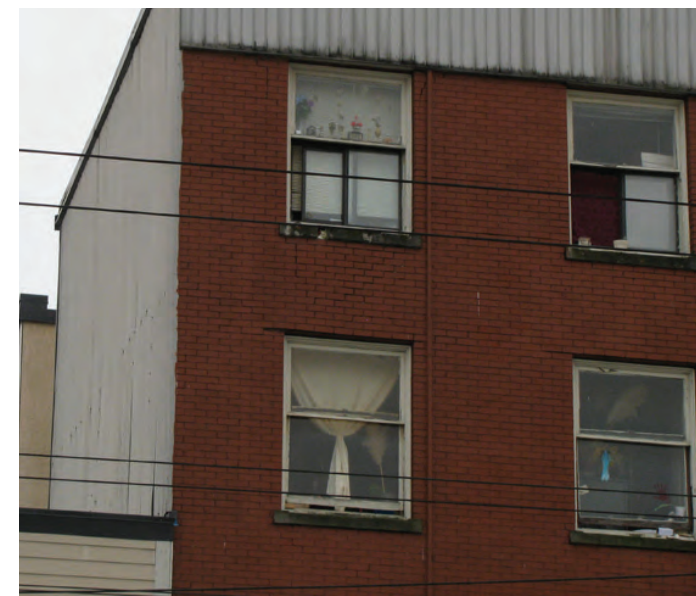
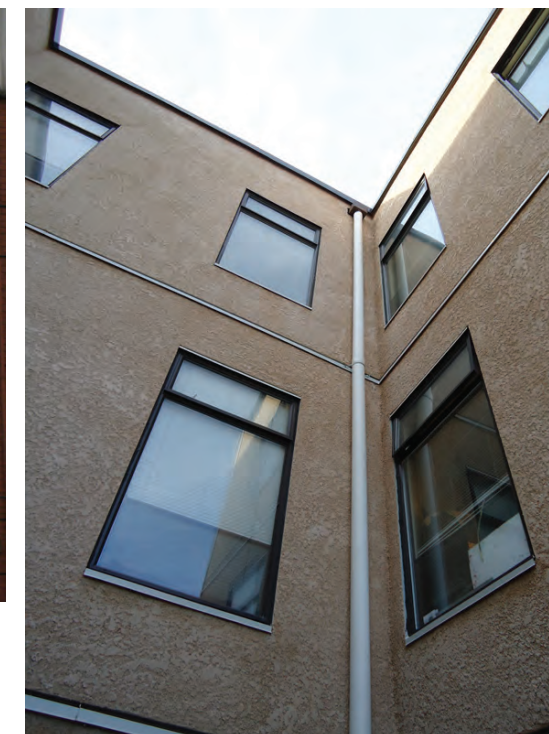
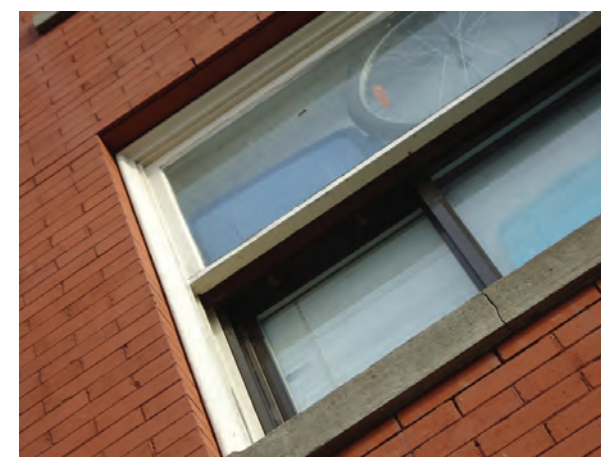
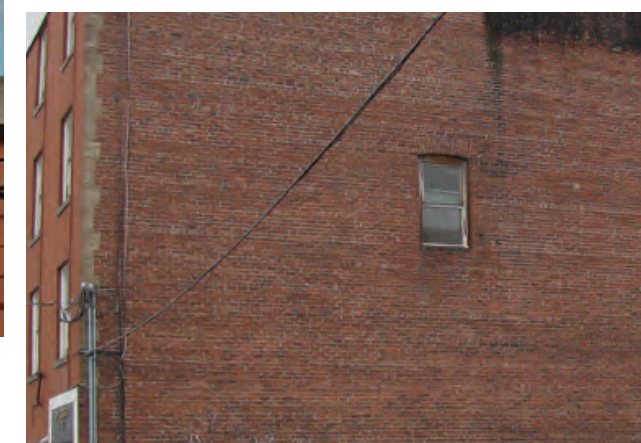
Existing window photo survey, Rice Block, Vancouver, 2012

The first, second and third floor windows were originally single glazed wood double hung windows. Most of these original windows have survived, but several on each façade have had both or single sash replaced with aluminum window inserts. The existing wood frames are in reasonable condition, but are in
