conservation plan

SUNRISE HOTEL

101 EAST HASTINGS STREET, VANCOUVER, BC

BC Housing's
"SRO Renewal Initiative"

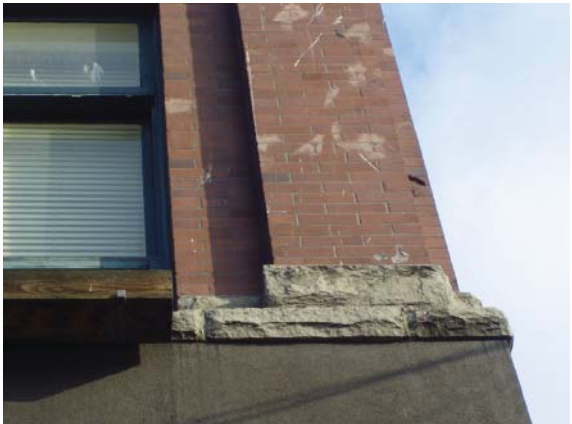
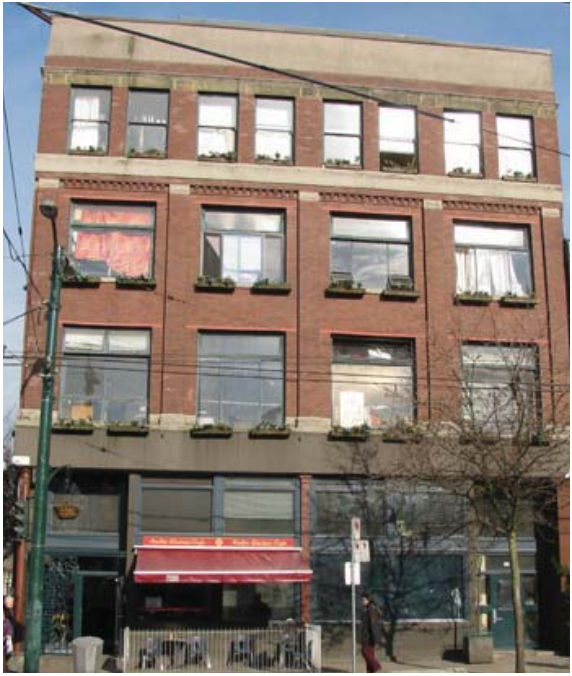
Condition Assessment Sunrise Hotel (Irving Hotel)		
Element	Description/Condition	Image Reference
Front Façade Masonry	The original red brick and stone trim masonry is generally in good condition, with minor mortar joint deterioration and wash out at areas of high water run-off. The sandstone trim is in good condition with minor spalling in areas. The original carved stone capitals on the pilasters were mindlessly bashed off in 1998, supposedly because they were deteriorated. The stone trim requires a full repointing.

The existing red face brick masonry will be restored through selective repointing and cleaning. The rock-faced sandstone sills, beltcourses, pilaster bases and 'capitals' and window headers will be scaled of any friable delaminated face, fully repointed and cleaned. Isolated spalling on horizontal and vertical surfaces of sills will be patched with a colour matched masonry restoration mortar.

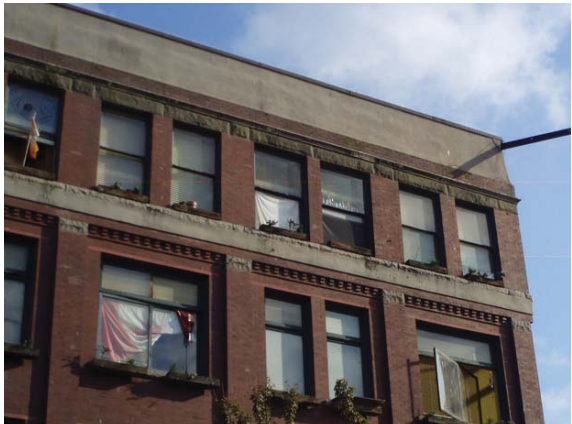
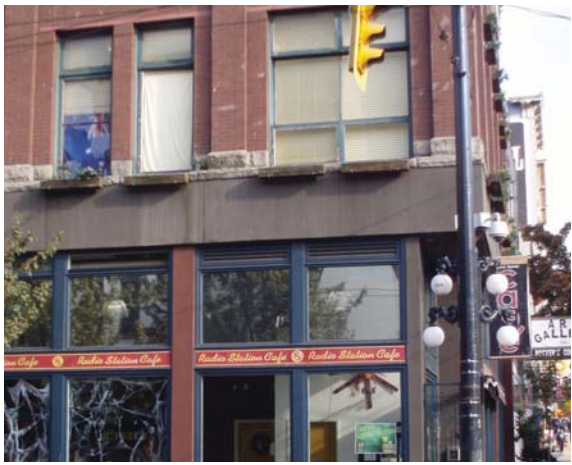
Condition Assessment Sunrise Hotel (Irving Hotel)		
Element	Description/Condition	Image Reference
Sheet Metal	The original impressive projecting bracketed sheet metal cornice, the sheet metal beltcourse between the second and third floors and sheet metal lower cornice have all been removed. Originally there were two imposing building sign pediments, one centered on the Hastings Street façade and one centered on the Columbia Street façade, and these have also been removed.

The missing sheet metal upper cornice, upper beltcourse, and lower cornice will be restored to the original configuration, and anchored back to the masonry wall as part of the envelope seismic stabilization structural upgrade. The sheet metal pediments at the parapet on the center of each elevation, including the articulated end piers and building sign panel, will be restored. The parapet cap will be replaced to allow masonry restoration and seismic bracing, and will be replaced to match the new and restored cornice sheet metal work.

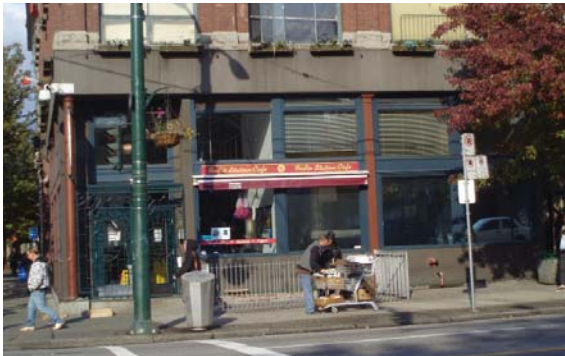
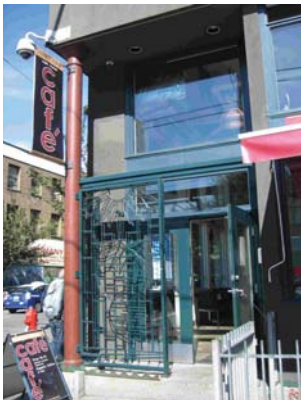
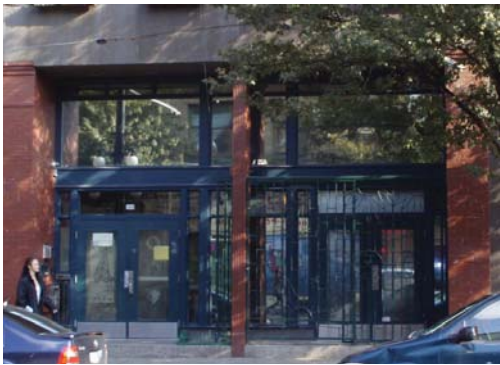
Condition Assessment Sunrise Hotel (Irving Hotel)		
Element	Description/Condition	Image Reference
Storefront	The ornamental cast iron columns that originally supported the storefront lintel have all survived, although some have been built-in behind wood or stucco cladding. The slender Doric style corner columns which accented the inset corner entry is still exposed and very impressive. No other elements of the original storefront have survived. The current storefront is a poor facsimile of the original and lacks heritage character.

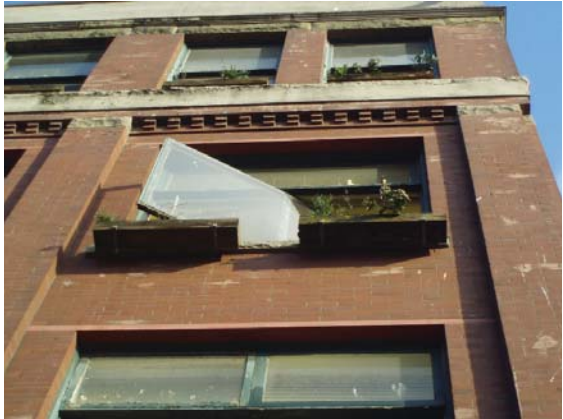
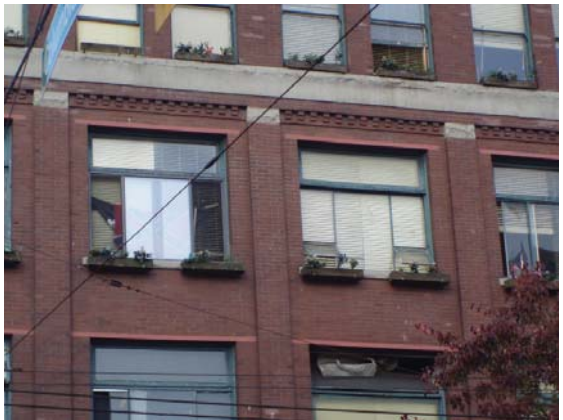
Condition Assessment Sunrise Hotel (Irving Hotel)		
Element	Description/Condition	Image Reference
Upper Front Façade Windows	<p>Many of the original first and second floor wood windows, including the large center pivot wood windows with single sash transom sash above, have survived on Columbia Street, but all of these have been retrofitted to aluminum sash in the original wood frames on Hastings Street. Most of the wood double hung windows, some with transoms, have survived on both street elevations.</p> <p>The original wood frames are in fair condition, and require refurbishing with some sill re-surfacing required. The original brick moldings are still in place, and in reasonable condition.</p>

The second and third floor windows on the Hastings Street elevation have been retrofitted with aluminum windows in the lower window sash space, where there was an original center pivot operable sash. The original wood hopper operable sashes are in place. The aluminum sash will be replaced with a new wood center pivot sash with double glazed units and a double row of pile weather stripping at horizontal friction lines and neoprene bulb weather stripping at vertical closure lines, and the hopper window operators retrofitted with threaded rod and yoke operators to facilitate ease of operation. The existing hopper window sash will be refurbished as required and retrofitted with new weather stripping, similar to the pivot sash. The center pivot sash will be fitted with metal stops on the sills to limit opening

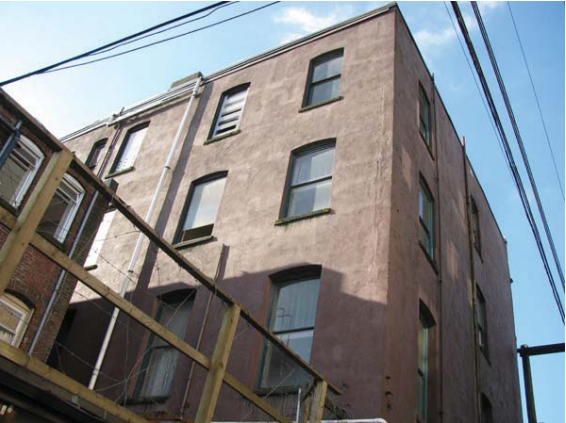
Condition Assessment Sunrise Hotel (Irving Hotel)		
Element	Description/Condition	Image Reference
Light Court Windows	The original light court window frames exist, but have been fitted with aluminum single glazed windows. The wood frames exist, but some sills are entirely rotted out and some jamb bottoms require scarf joint patches. The light court windows range from 18" to 4'-0" from the property line.

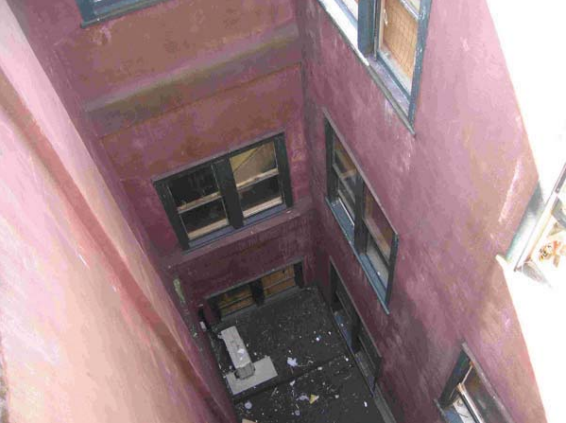
Light Well Windows	The original light court window frames and sash exist, but the sashes are in poor condition. The north light well windows have been blocked in for the construction of the shower. The wood frames are in fair condition, but some sills will require resurfacing and some jamb bottoms require scarf joint patches. The original brick molding is in place, but also requires some scarf joint patches at the sill.

The light well rendering is cracked and spalled and reached the end of its service life. This wall will be re-clad in new rainscreen metal cladding.

Light court and light well rendering has reached the end of its service life and will be replaced with a new rainscreen corrugated metal cladding system, with through-wall and header flashing systems.

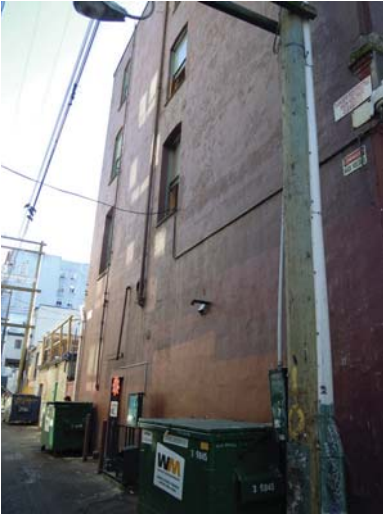
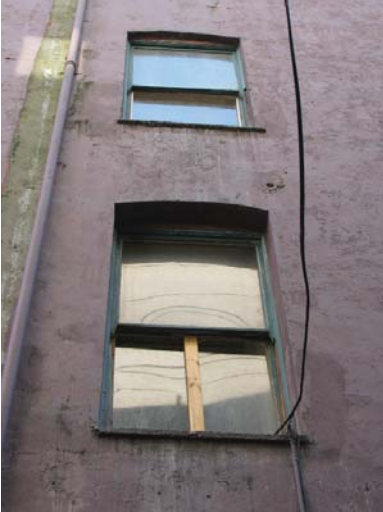
Condition Assessment Sunrise Hotel (Irving Hotel)		
Element	Description/Condition	Image Reference
Rear Windows	The original rear wood double hung windows are in place and in fair condition. The frames and original brick moldings are in fair condition, with some sills requiring resurfacing and some jambs may require scarf joint patches at the sill. The original brick molding is also in place, but also requires some scarf joint patches at the sill.

New double glazed aluminum or metal clad windows approximating the original double hung configuration will be installed in the original refurbished wood frames. Allow for new wood sills to match the originals, which are deteriorated. Install new scarf-jointed jamb bottom patches and brick mold patches, as required.

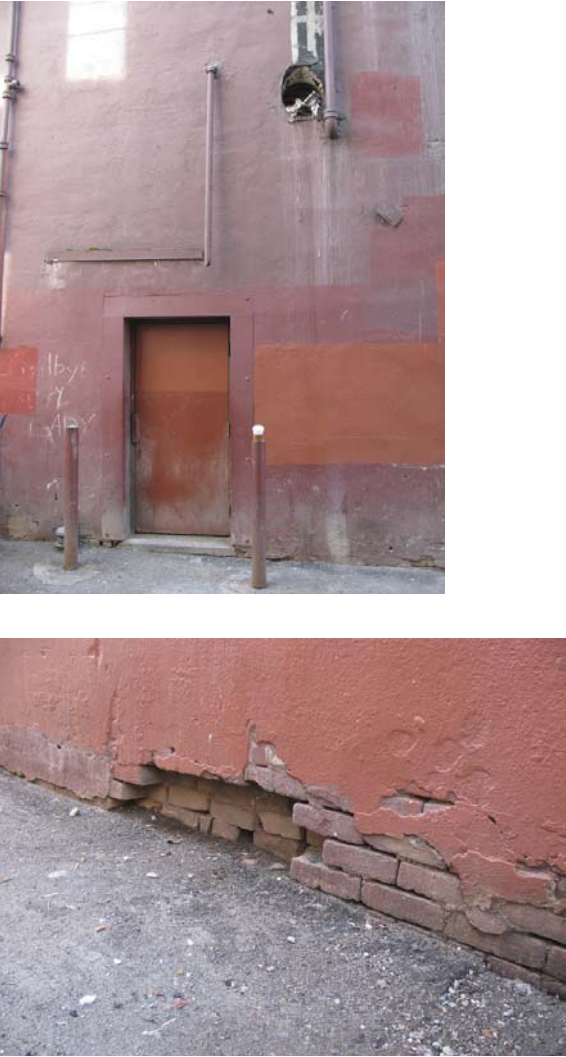
Condition Assessment Sunrise Hotel (Irving Hotel)		
Element	Description/Condition	Image Reference
Rear Façade Masonry	The rendering on the original brick masonry has spalled and cracked in a number of isolated areas.

The east elevation light court and rear façade rendering will be scaled back to solid substrate where spalling, bulging or cracking has occurred, and patched with a cementitious rendering which matches the current rendering in texture and colour. The existing rendering will be cleaned, prepared and re-painted with masonry paint.

Loose, bulging, or cracked rendering on the rear façade brick will be scaled off to brick and patched with a cementitious rendering matching the existing in texture, and all of the rendering will be prepared and painted with masonry paint.

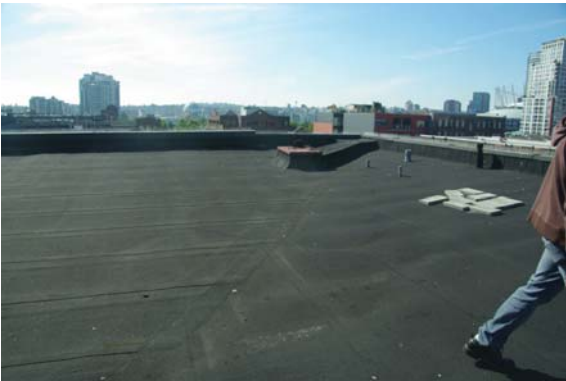
Condition Assessment Sunrise Hotel (Irving Hotel)		
Element	Description/Condition	Image Reference
Roof Surface	The roof surface sits on a light wood frame and roof board construction, built to slope to scupper drains at the light court. The current SBS roof surface is fairly new, as are the parapet cap flashings and scupper drains.

life remaining. However, upgrades to the brick parapets will damage the perimeter, and it may be cost effective to replace this roof surface. New enamelled galvanized parapet cap flashings and scupper drains will be installed.

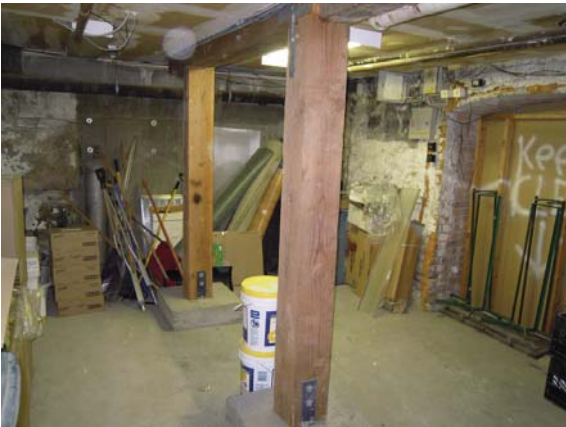
Structure	The original rubble granite masonry foundation wall, timber beams, steel I-beams and columns supporting the exterior wall, post and beam framing on the upper floors, and the wood laminated floor structure have all survived.

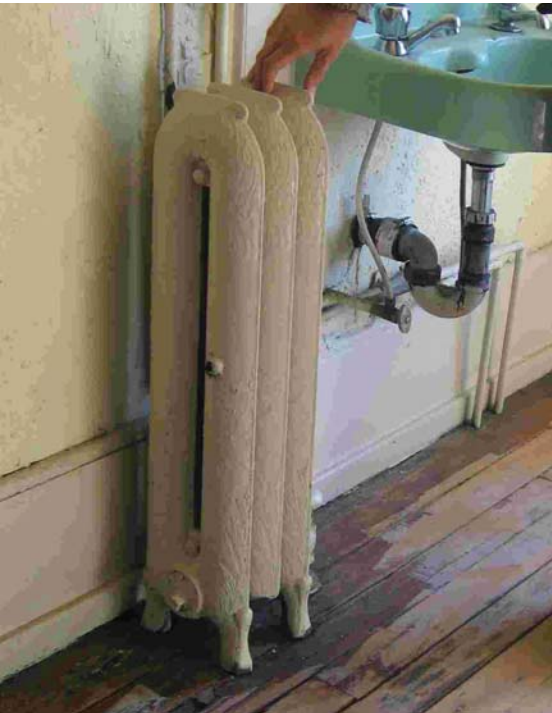
Condition Assessment Sunrise Hotel (Irving Hotel)		
Element	Description/Condition	Image Reference
Interior Features	A fair amount of original interior detailing has survived, such as the original wood stair balustrade, some original three panel wood suite doors, door and window casings, and baseboard. Original cast iron radiators exist and have an ornamental character.

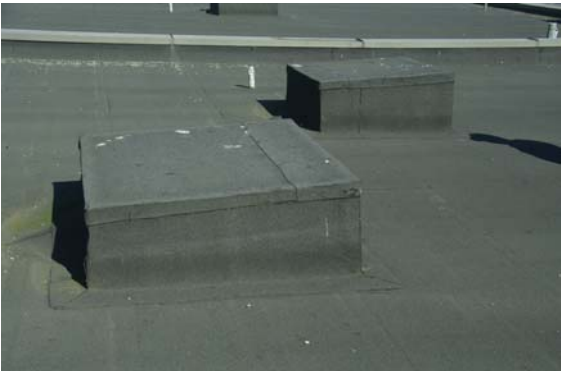
Condition Assessment Sunrise Hotel (Irving Hotel)		
Element	Description/Condition	Image Reference
Skylights	The original skylights over the 3rd floor corridor have been covered over at the roof, but the curbs still exist.

- 6.7 Rear Façade Features – The existing cementitious rendering will be repaired.
- 6.8 Skylights – The two skylights over the third floor corridor will be re-instated.

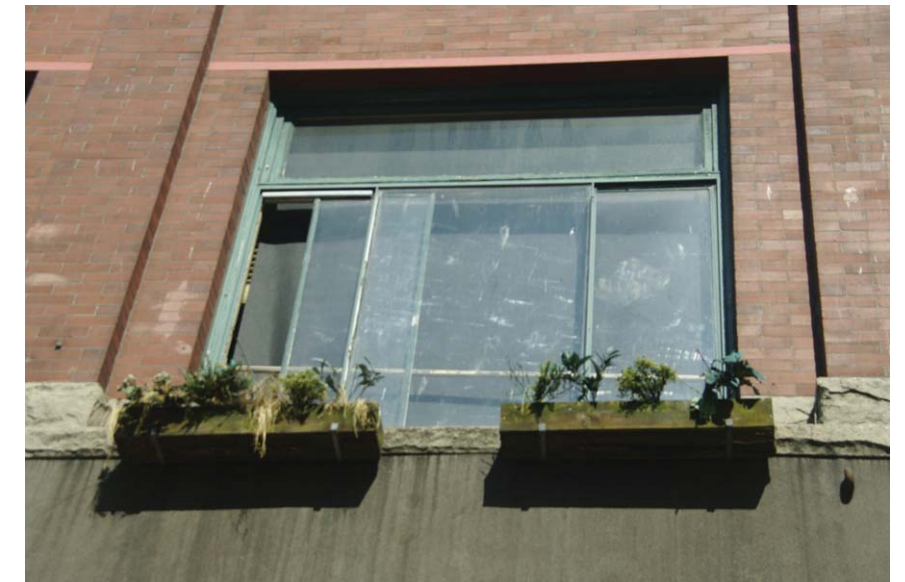
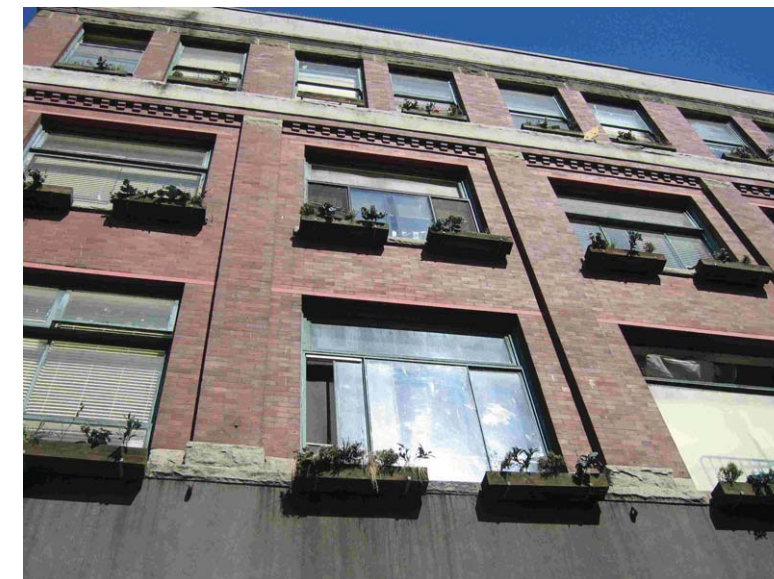
Existing windows, Sunrise Hotel, 2011

All of the third floor wood double hung windows are in place; the frames are in fair condition, but the sashes have reached the end of their service life. The existing frames, sills, and brick mold will be rehabilitated, with some sills requiring resurfacing for surface deterioration, some jambs and brick mold bottoms requiring scarf joint Dutchman patch repair. Provide new wood sash to the original profile, excepting slight molding profile variances, and fit with new sealed double glazed units, with a low E coating on surface 3, and fit with a Superseal glazing seal. Provide a wood stop on the inside of the sash, sealed with a bead of clear silicone sealant. Provide two lines of regletted pile weather stripping around the perimeter of each sash. Refurbish the weights, pulleys and cords for the new sash weight, refurbish existing cam closers and pulls, or provide new matching if the existing are missing or unserviceable.

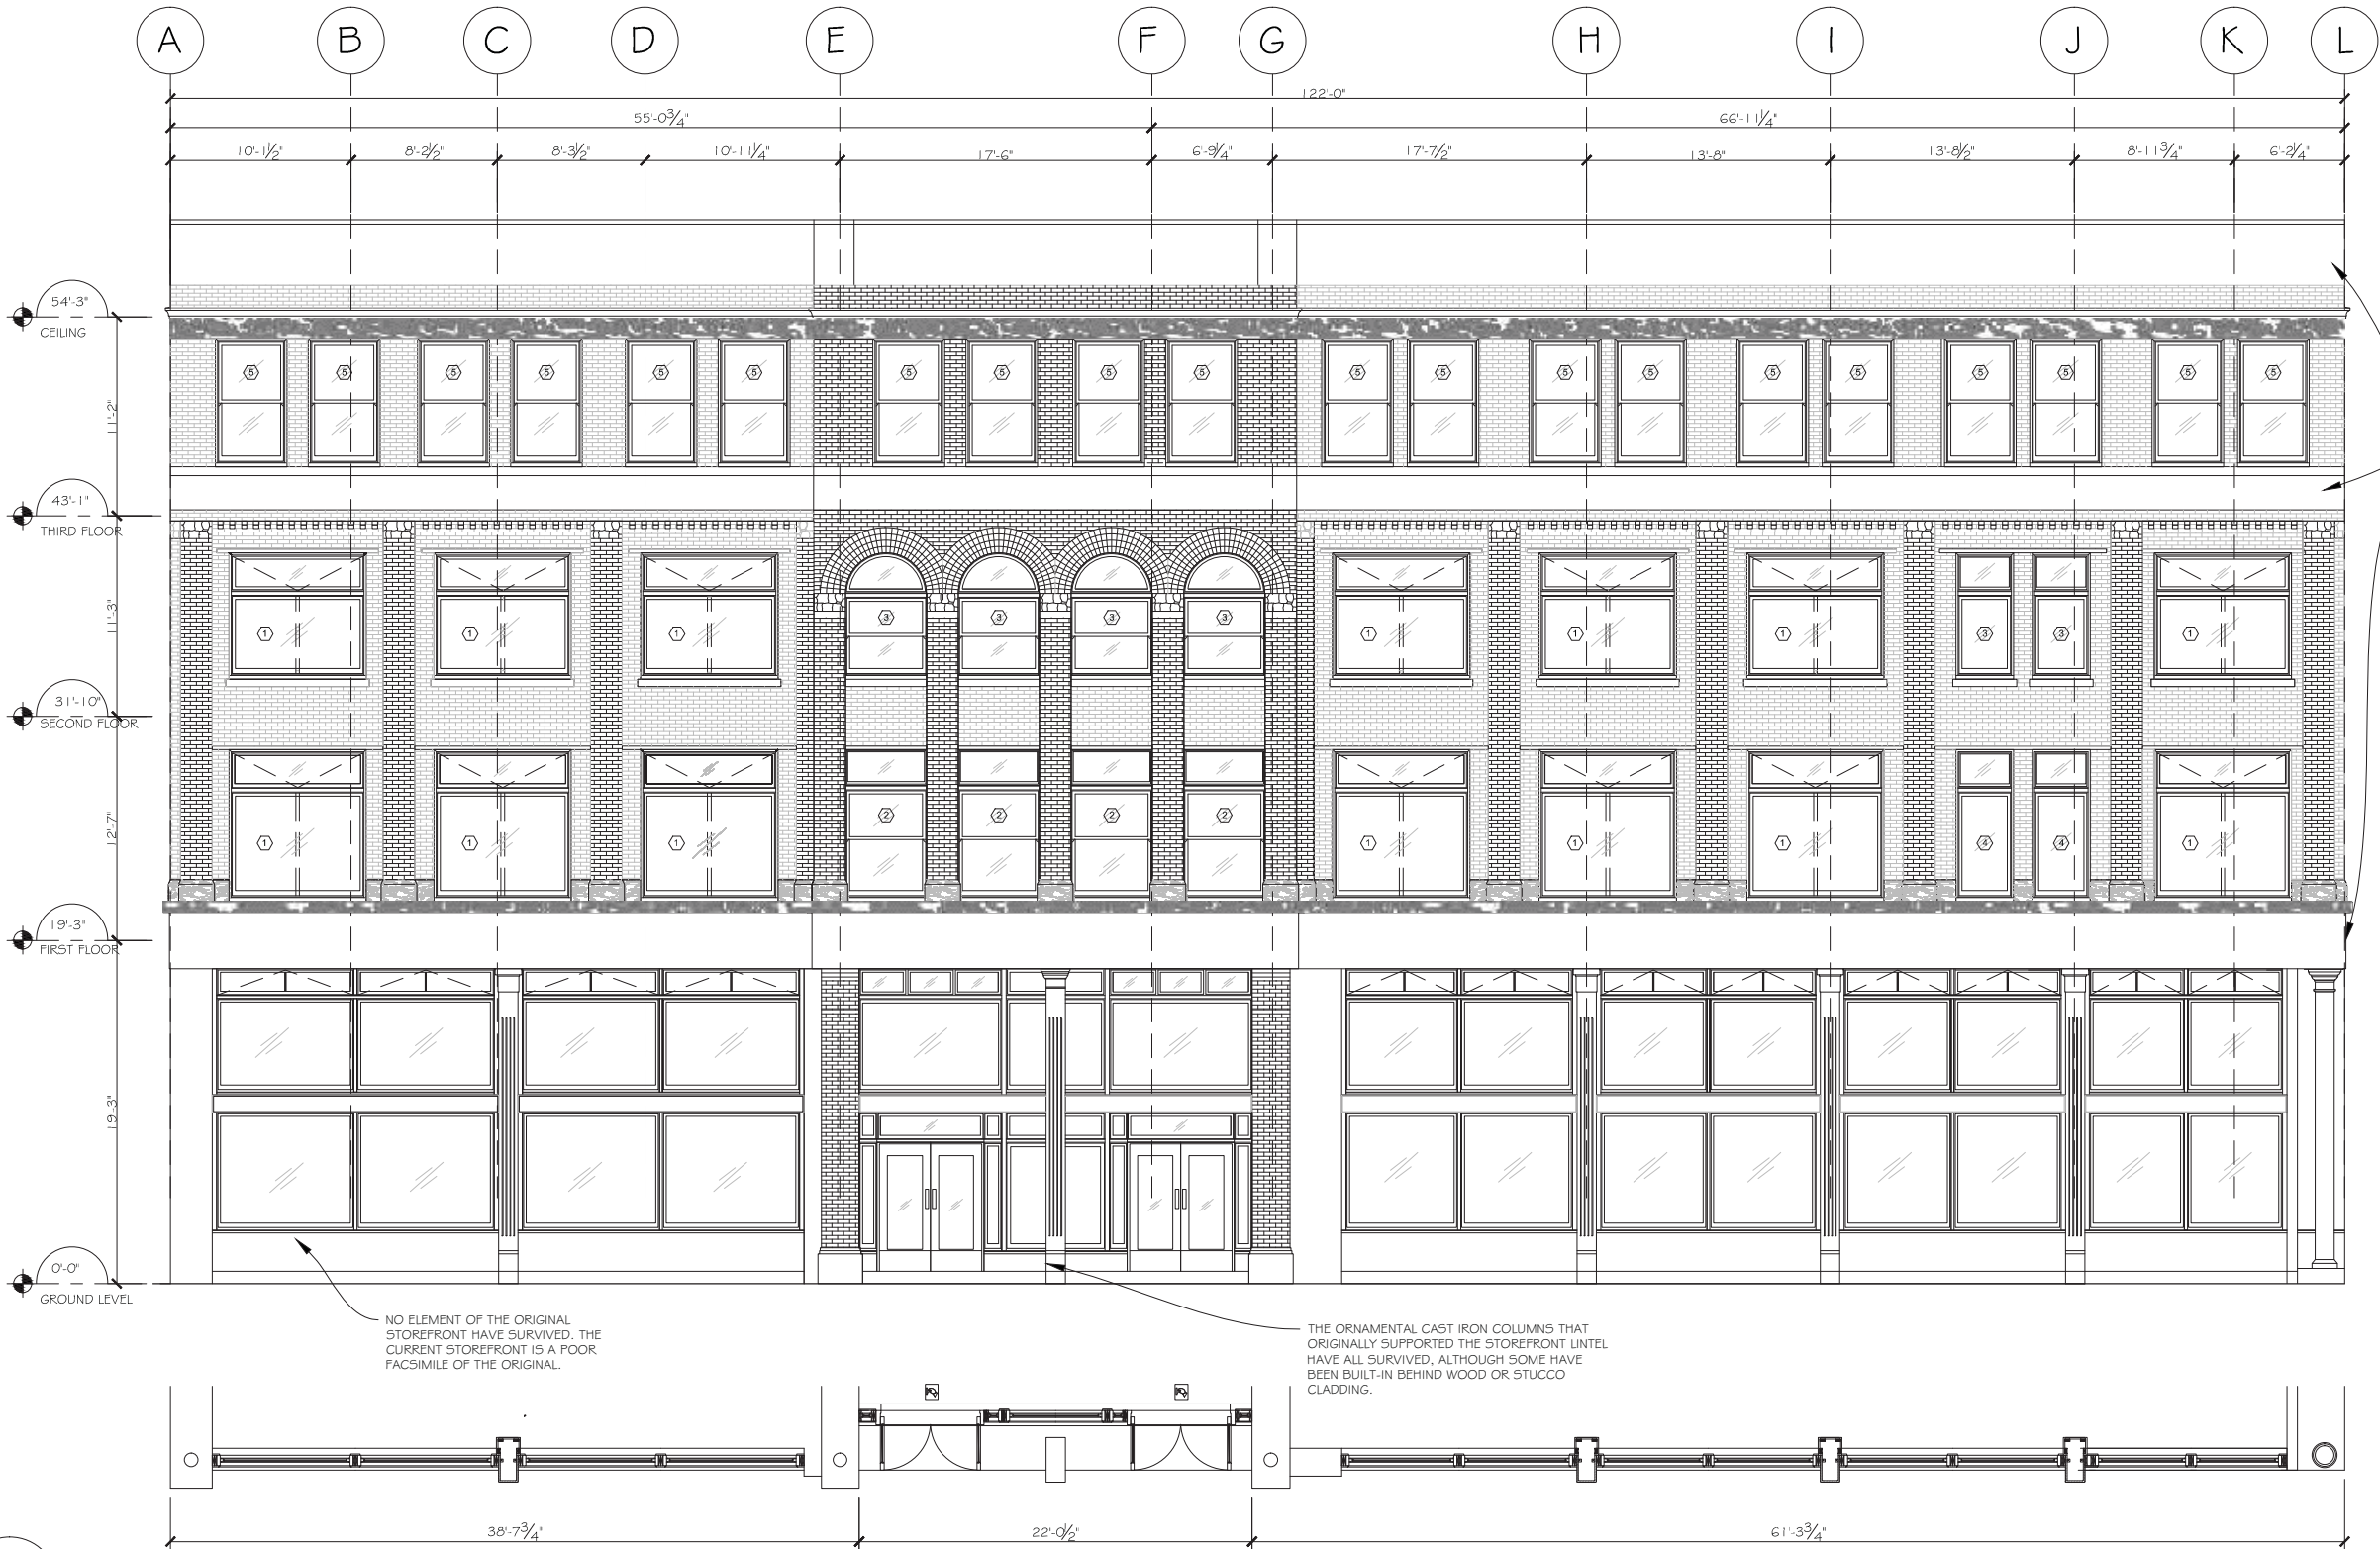
A-EX-201

THE ORIGINAL IMPRESSIVE PROJECTING BRACKETED SHEET METAL CORNICE, THE SHEET METAL BELTCOURSE BETWEEN THE 2nd & 3rd FLOORS AND SHEET METAL LOWER CORNICE HAVE ALL BEEN REMOVED.

ORIGINALLY THERE WERE 2 IMPOSING BUILDING SIGN PEDIMENTS, ONE CENTERED ON THE HASTINGS STREET FACADE AND ONE CENTERED ON THE COLUMBIA STREET FACADE AND THERE ARE REMOVED.

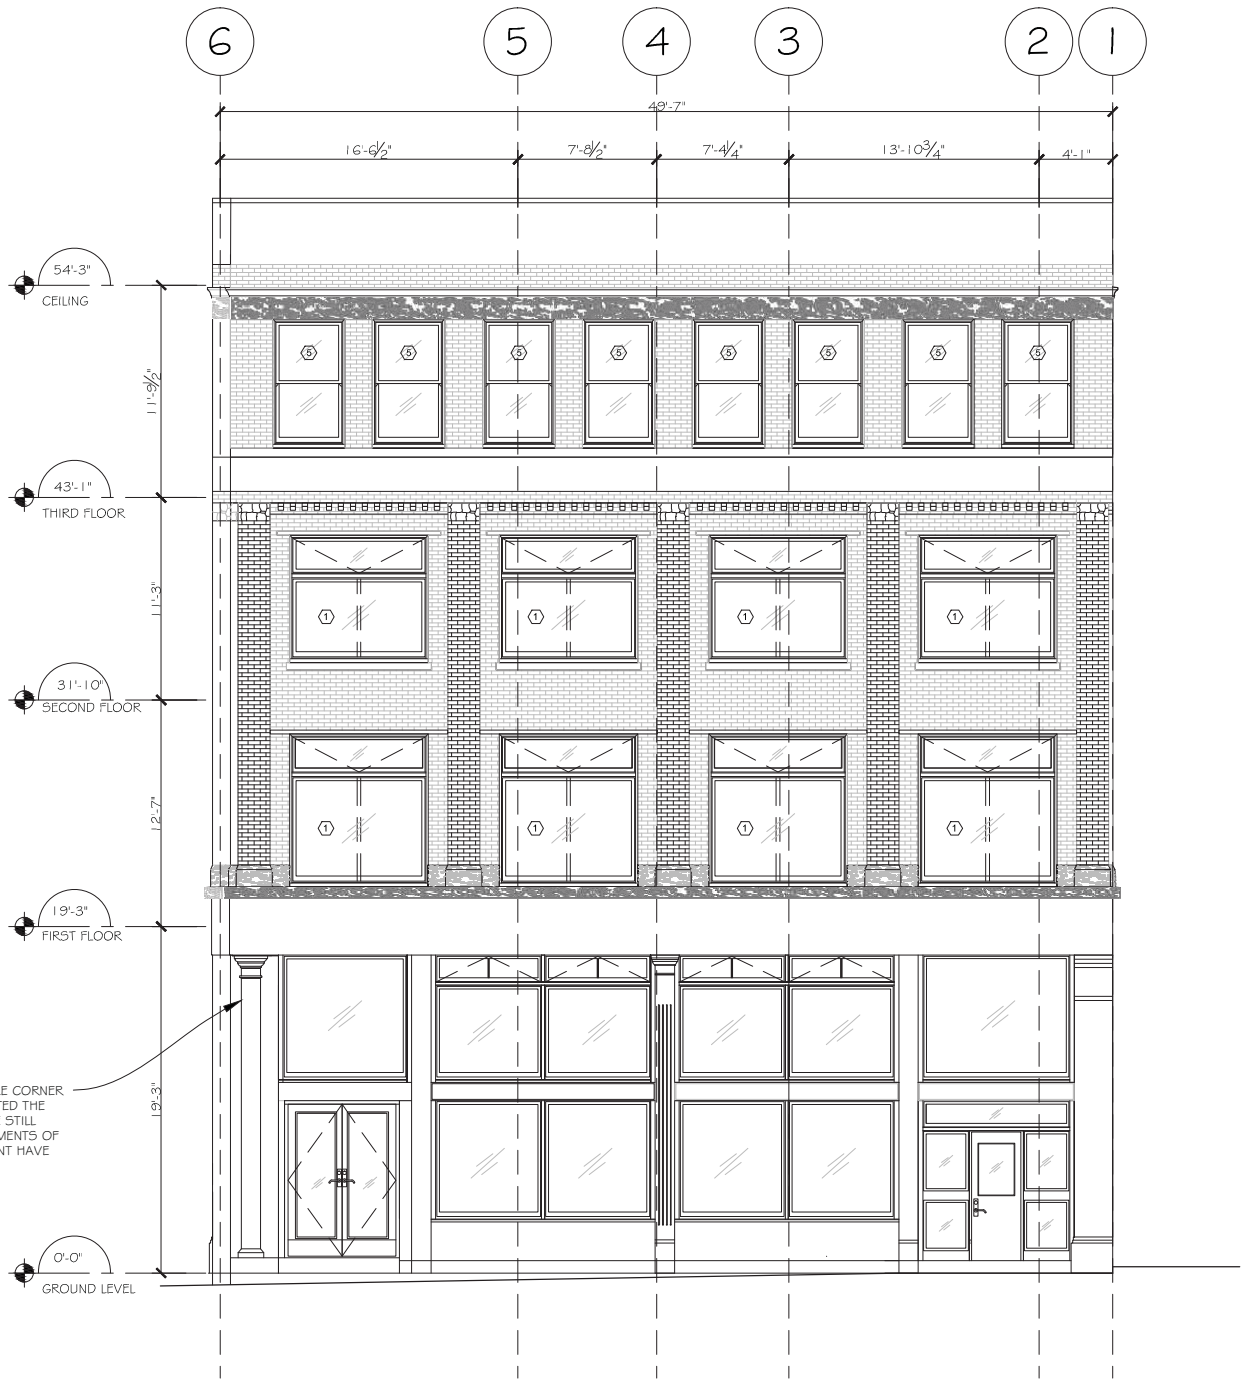
1 Existing South Elevation - Hastings Street
SCALE: $\frac{3}{16}'' = 1'-0''$

THE SLENDER DORIC STYLE CORNER COLUMNS WHICH ACCENTED THE INSET CORNER ENTRY ARE STILL EXPOSED. NO OTHER ELEMENTS OF THE ORIGINAL STOREFRONT HAVE SURVIVED.
