conservation plan

RICE BLOCK

404 HAWKS AVENUE, VANCOUVER, BC

McGinn Engineering & Preservation Ltd./
BARRY MCGINN ARCHITECT

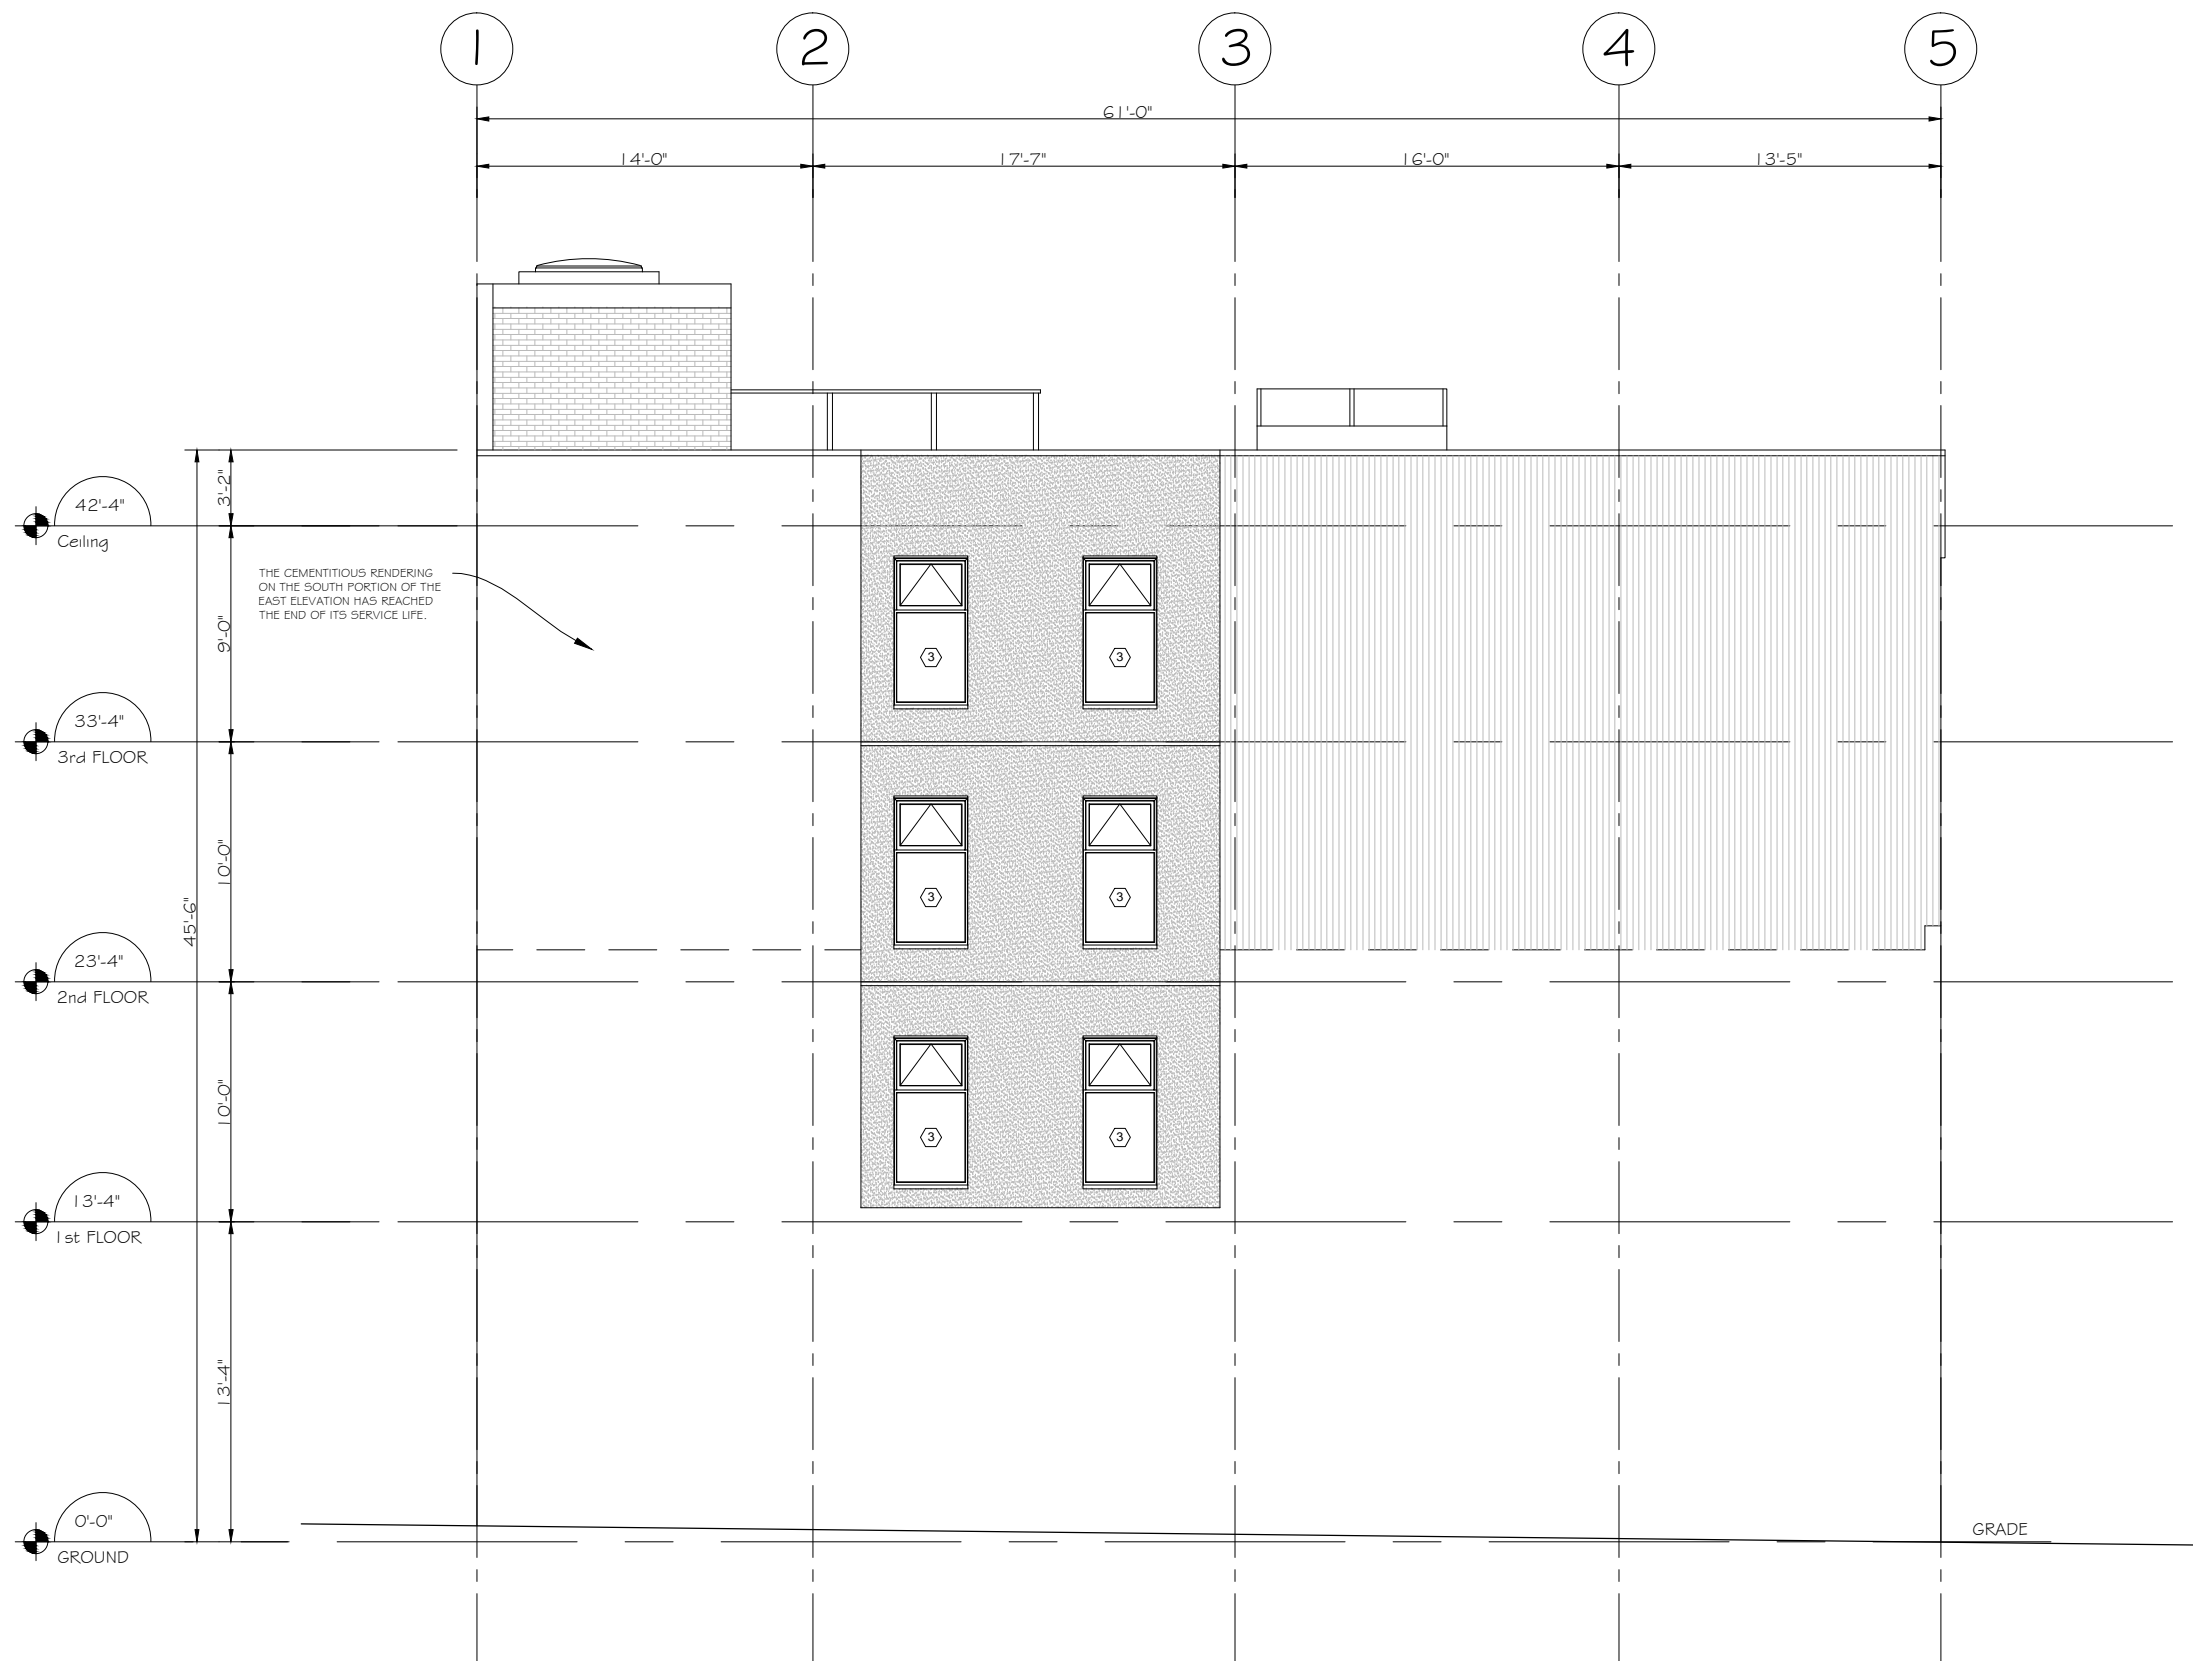
A-EX-202

- 6.7 **East Elevation Wall** – A new rainscreen wall with corrugated metal cladding will be installed over the failed cementitious rendered walls at the east property line.

1 Existing East Elevation
SCALE: $\frac{1}{4}" = 1'-0"$

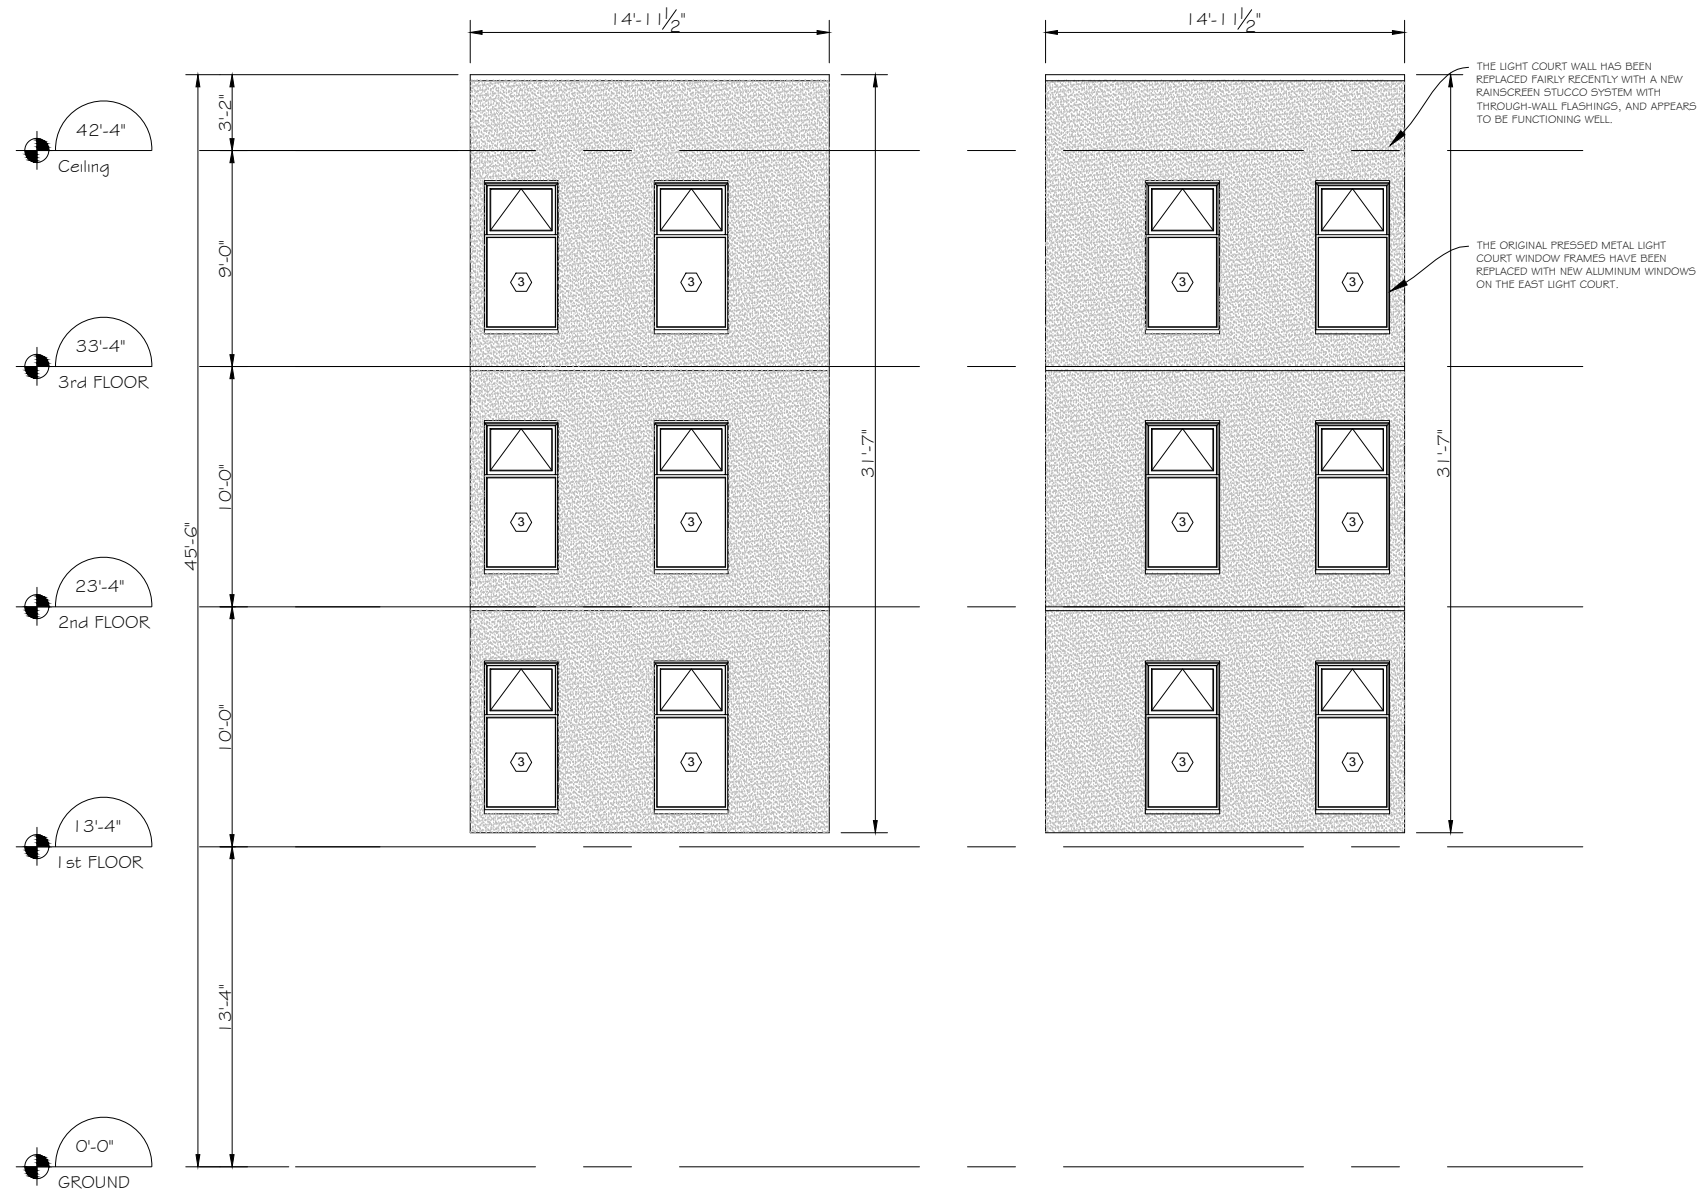
A-EX-204

The light court wall has been recently clad in a rainscreen sheet metal cladding system, and is in good condition.

1 Existing Lightcourt Elevations
SCALE: $\frac{1}{4}'' = 1'-0''$

3	ALUMINUM FIXED/ AWNING	LIGHT COURT & EAST FAÇADE	THE ORIGINAL PRESSED METAL EAST ELEVATION & LIGHT COURT WINDOW FRAMES HAVE BEEN REPLACED WITH NEW ALUMINUM WINDOWS ON THE EAST LIGHT COURT.	THE EXISTING ALUMINUM FIXED/AWNING OPERATION LIGHT COURT & EAST FACADE WINDOWS HAVE BEEN RECENTLY INSTALLED AND ARE IN GOOD CONDITION AND OPERATING FINE.

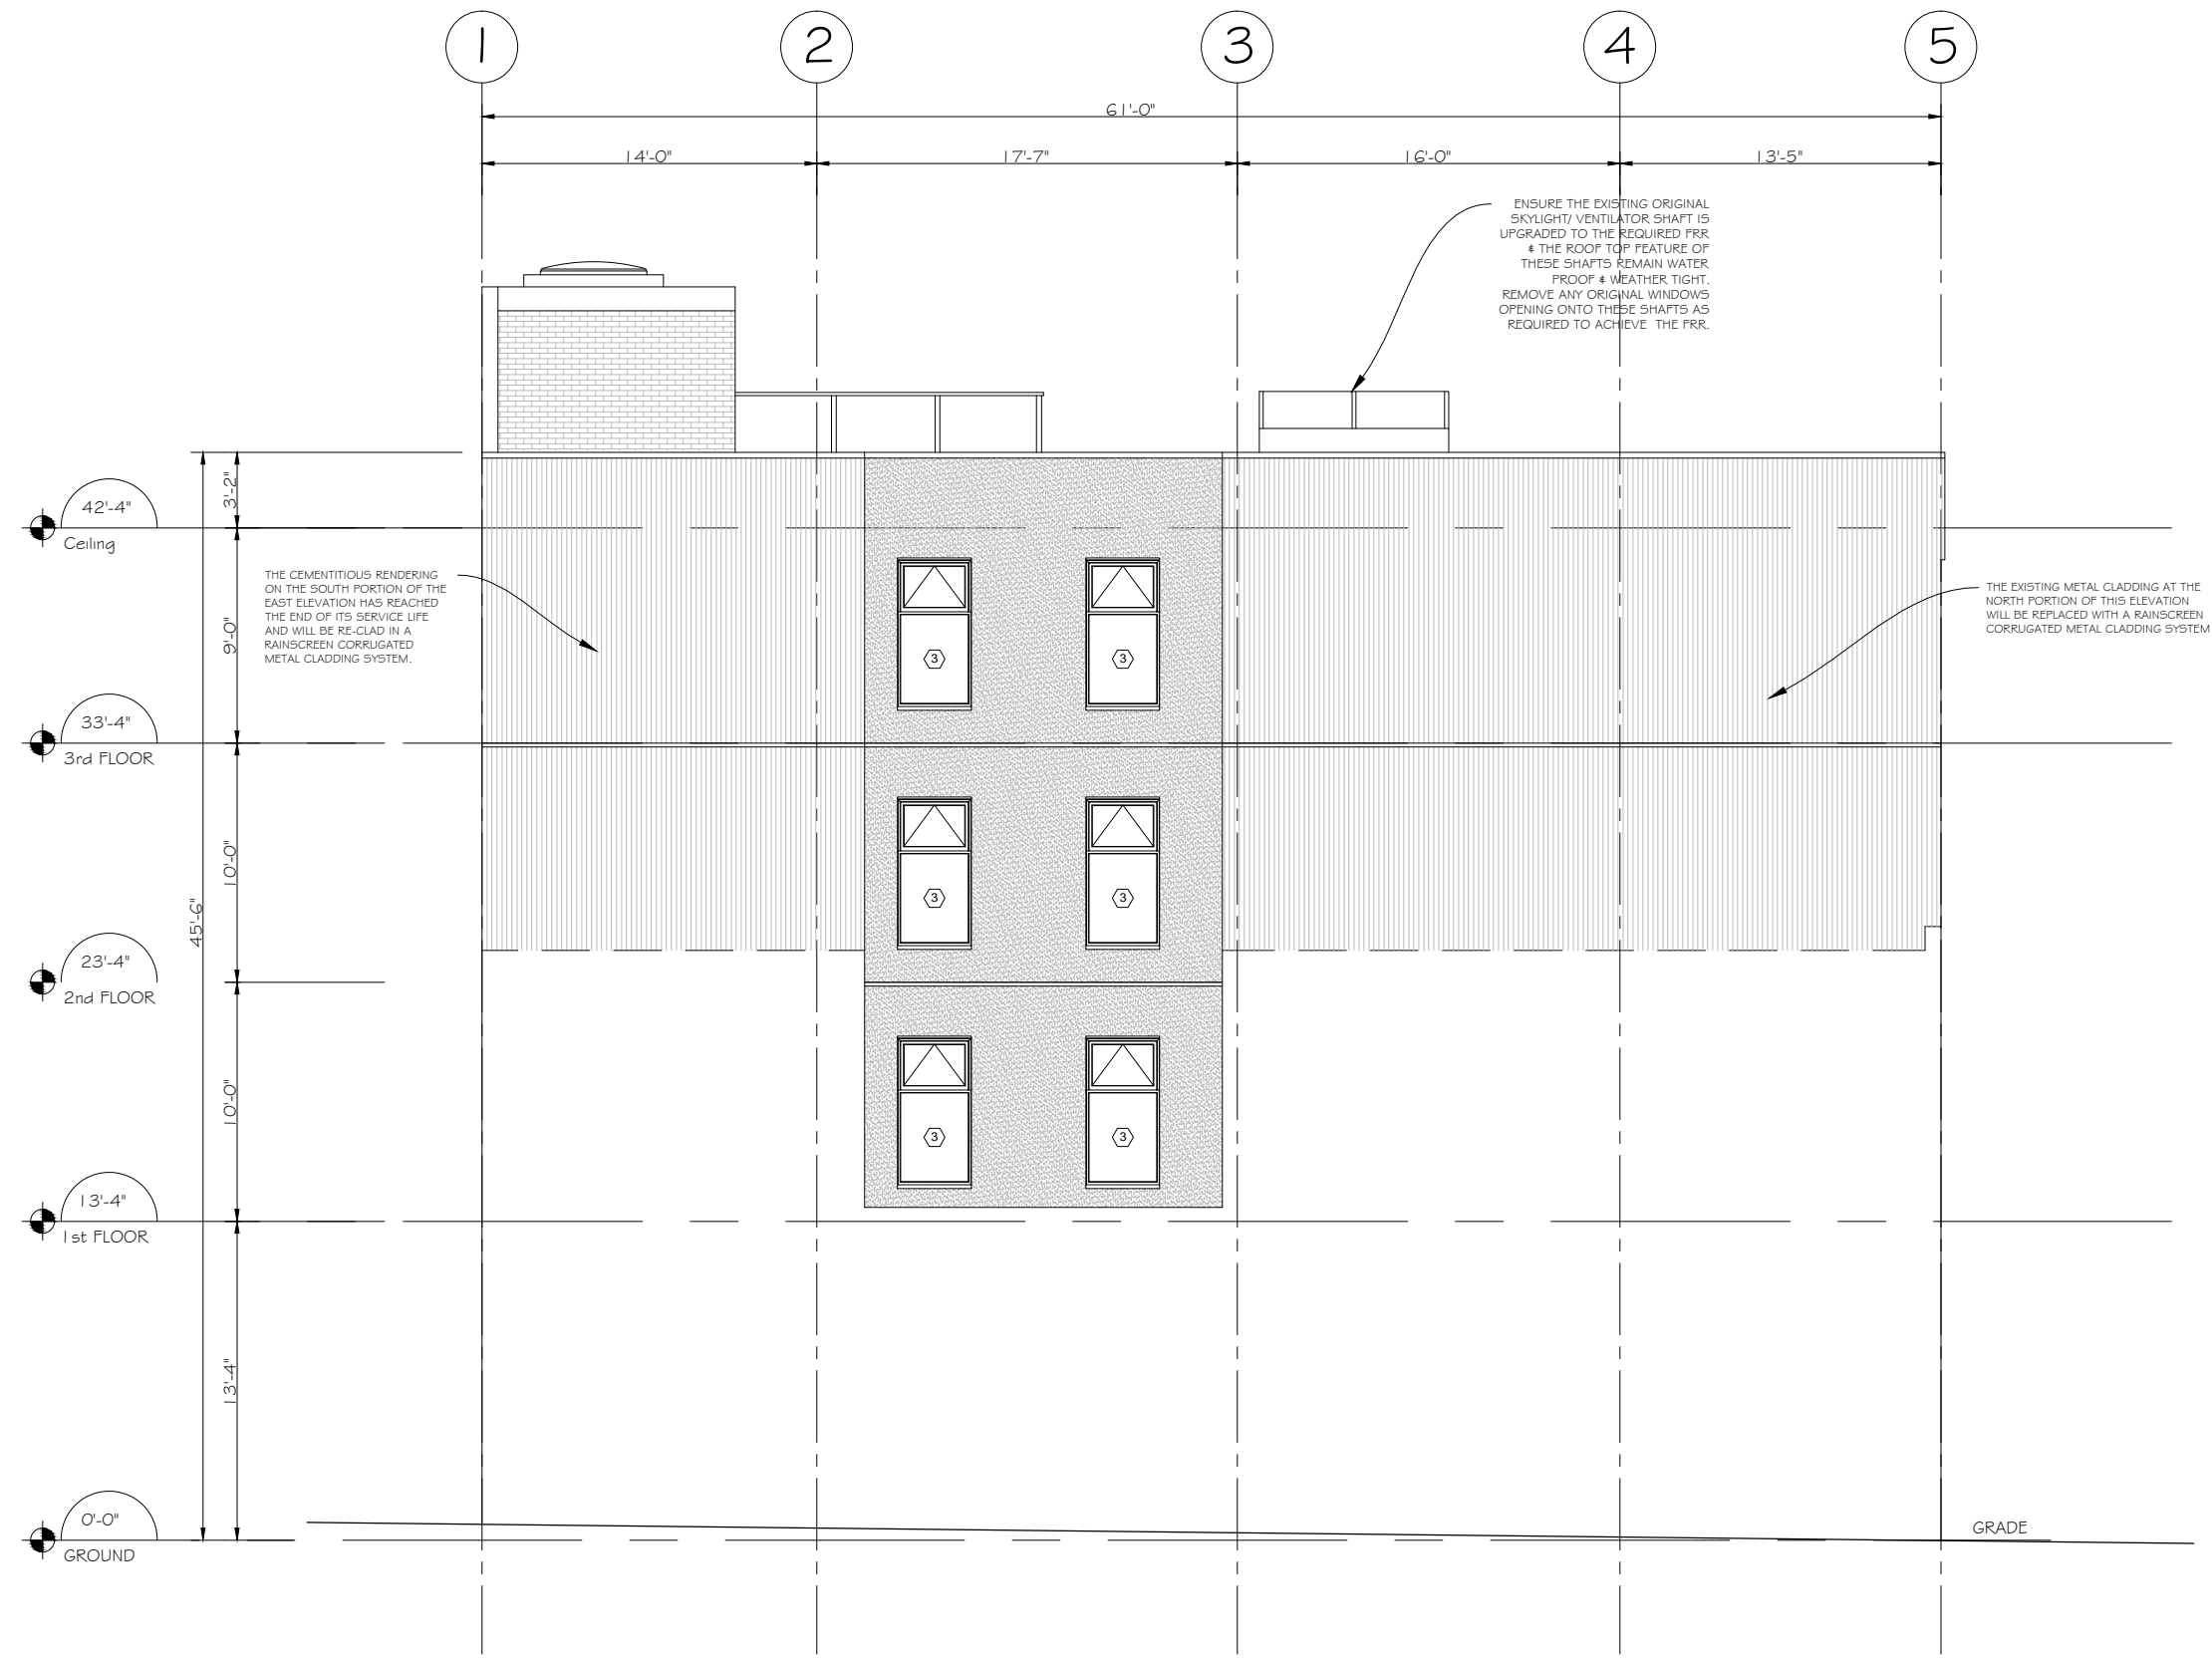
A-PR-203

1 Proposed East Elevation
SCALE: $\frac{1}{4}" = 1'-0"$

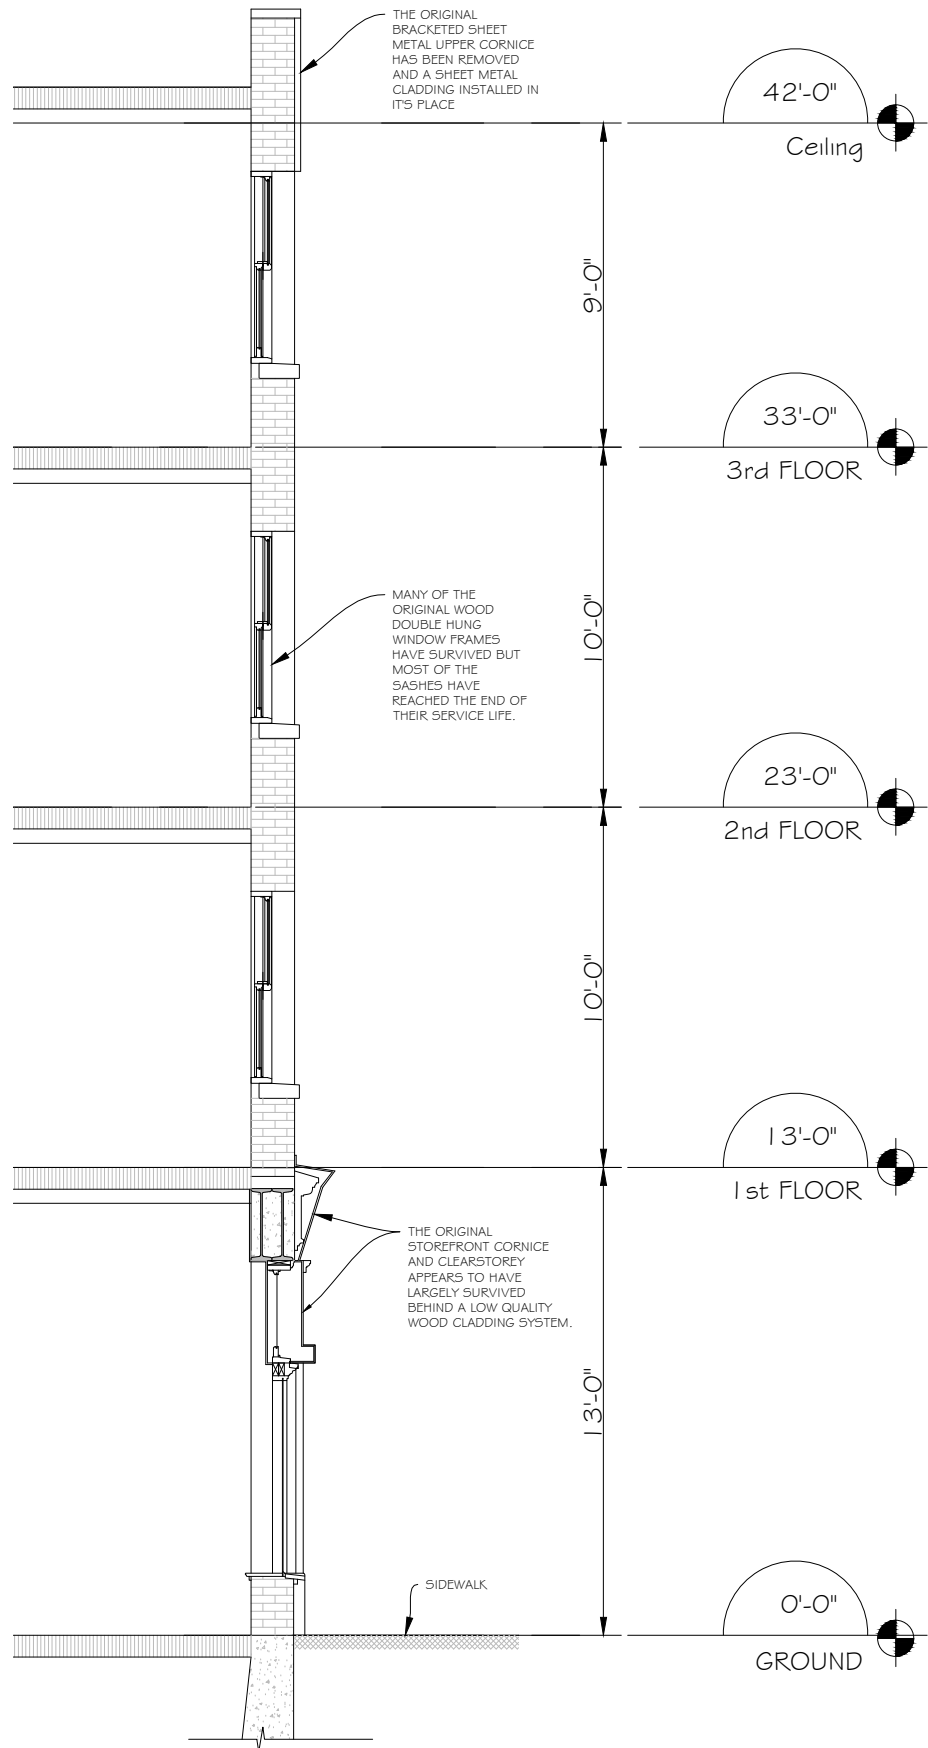
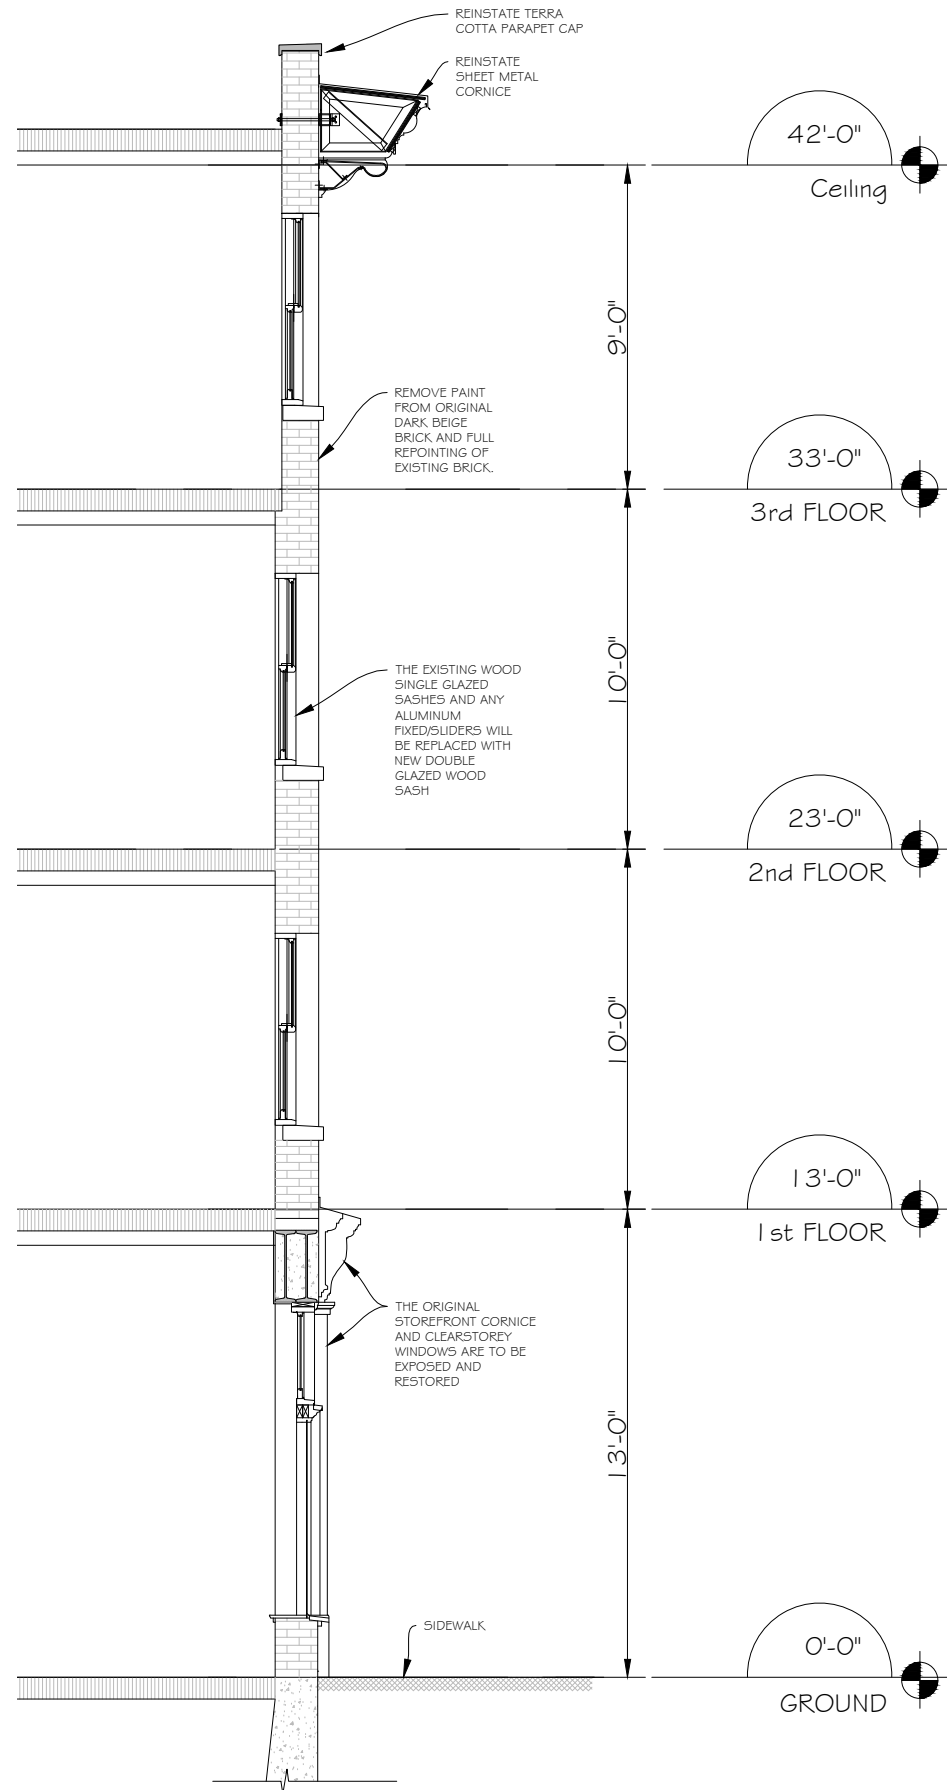
DWG#:
A-PR-205

1 Existing Storefront Section
SCALE: $\frac{1}{4}" = 1'-0"$

2 Proposed Storefront Section
SCALE: $\frac{1}{4}" = 1'-0"$

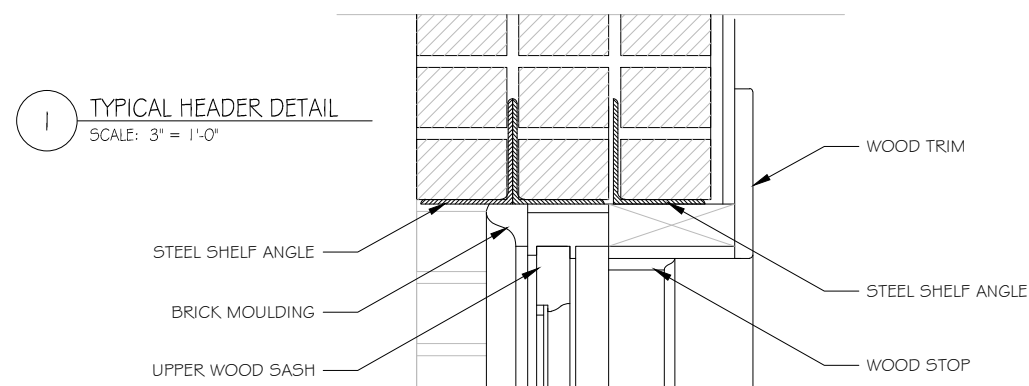
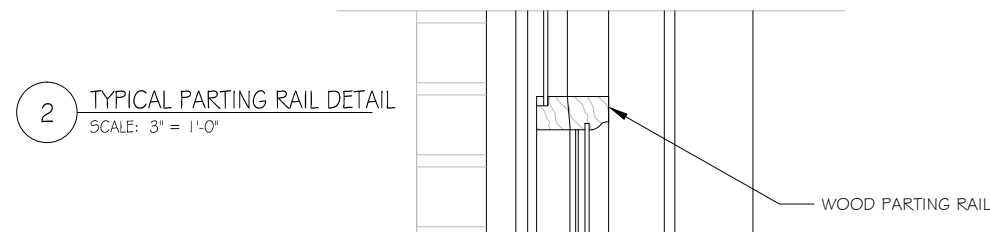
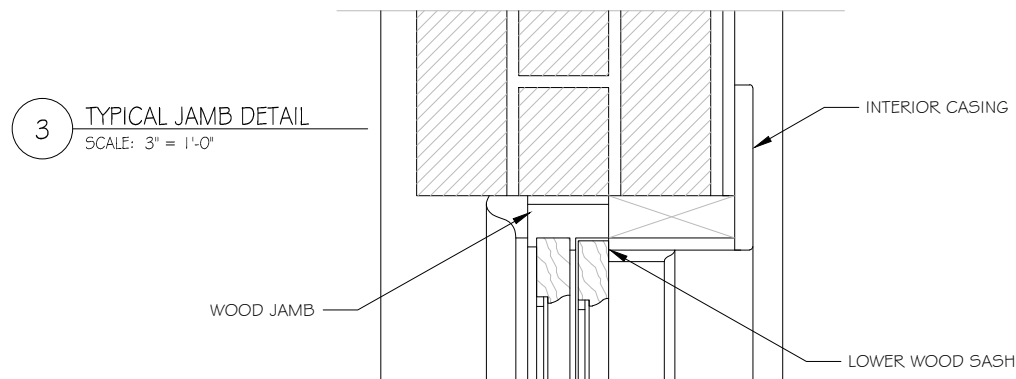
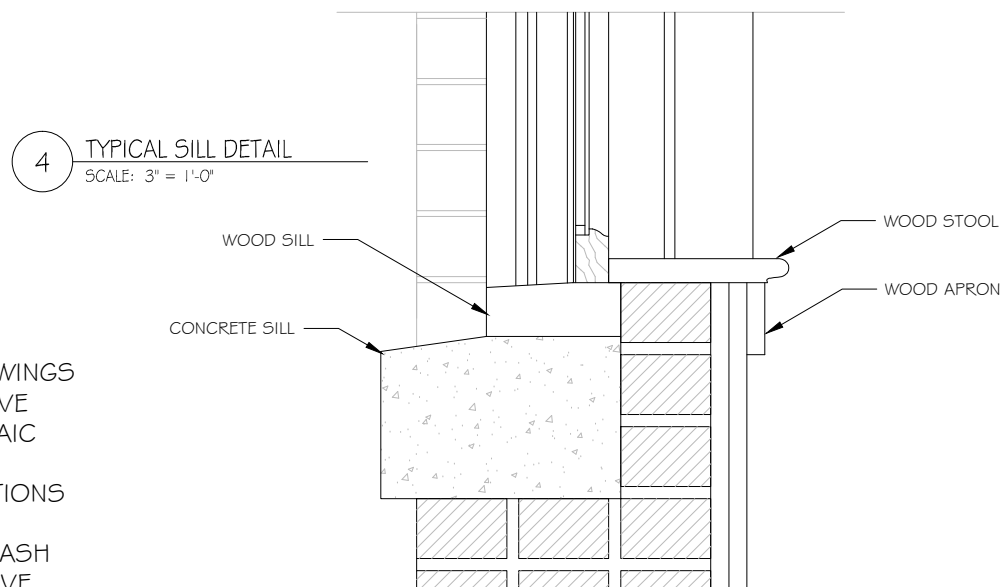
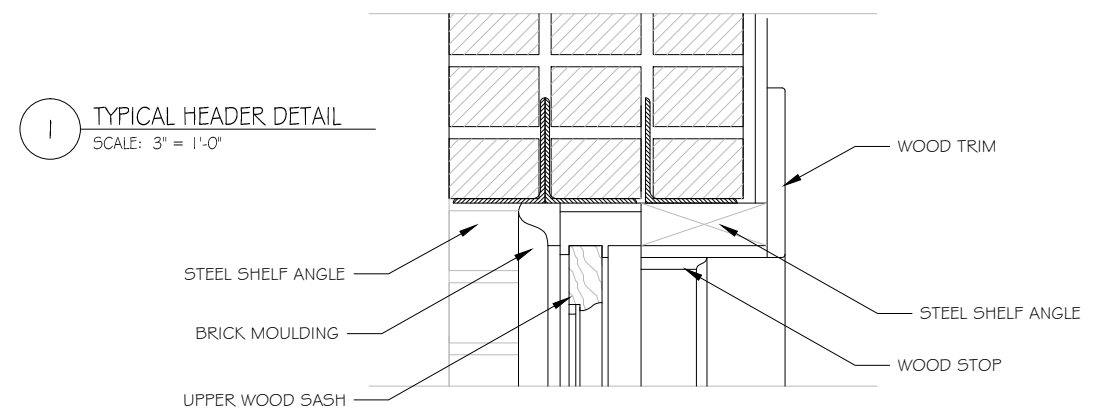
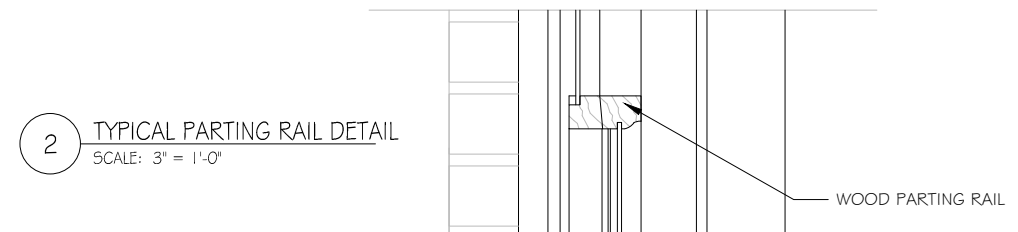
A-PR-301

2. ORIGINAL WOOD WINDOW SASH DETAILED. SOME WINDOWS HAVE BEEN FITTED WITH ALUMINUM WINDOW INSERTS AND SHOULD BE REPLACED WITH NEW WOOD SASH MATCHING THE ORIGINAL PROFILE.

frames, and rehabilitation with wood double glazed double hung sash. Replace any aluminum insert lower sash with new double glazed wood lower sash with the same profile as the existing wood lower sash found on other upper façade windows.

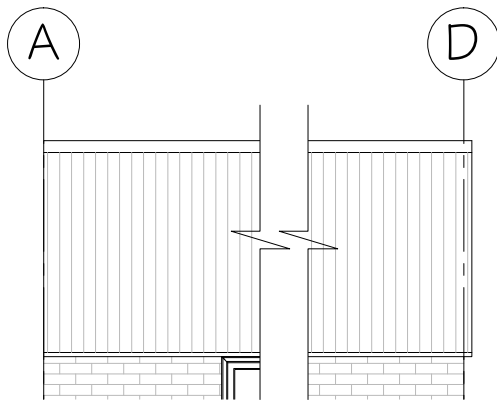
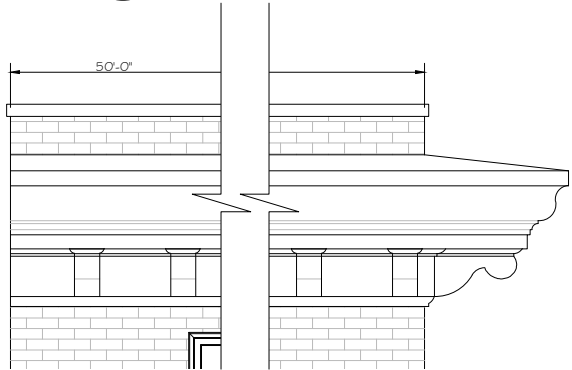
A-PR-402

1 EXISTING UPPER CORNICE ELEVATION - NORTH
SCALE: $\frac{1}{2}" = 1'-0"$

2 PROPOSED UPPER CORNICE ELEVATION - NORTH
SCALE: $\frac{1}{2}" = 1'-0"$

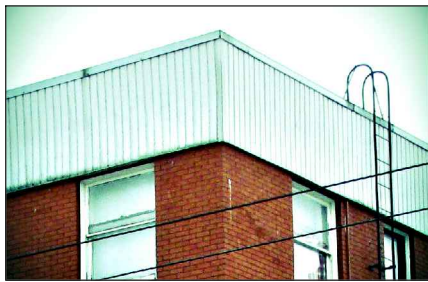
existing cornice, NW corner

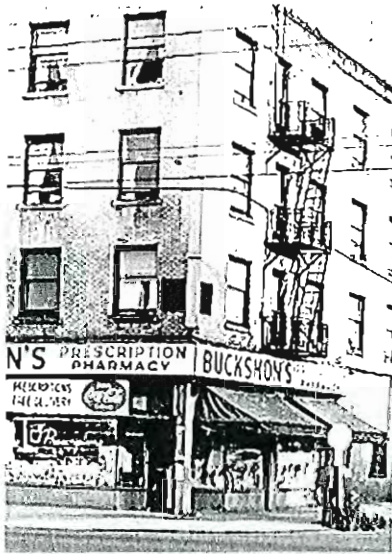
Front Façade Trim – Original and Base Paint Layer - Recommended Colour

Trim
(Upper windows & storefront frames/sash,
brick mould, sill, upper & lower cornices)
