conservation plan

SUNRISE HOTEL

101 EAST HASTINGS STREET, VANCOUVER, BC

BC Housing's
"SRO Renewal Initiative"

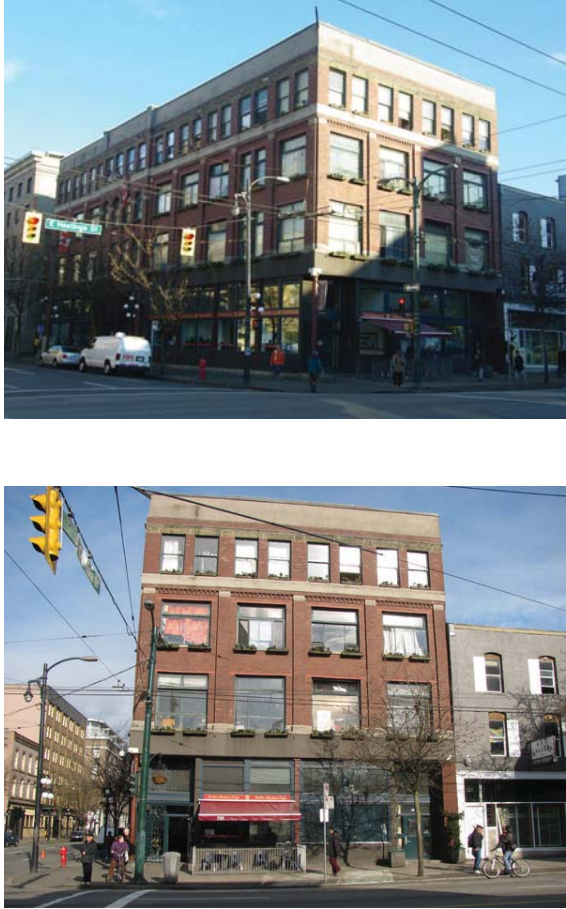
Condition Assessment Sunrise Hotel (Irving Hotel)		
Element	Description/Condition	Image Reference
Form, Scale and Massing	No significant alterations or additions have affected the building's form scale and massing and these aspects of the building are essentially original.

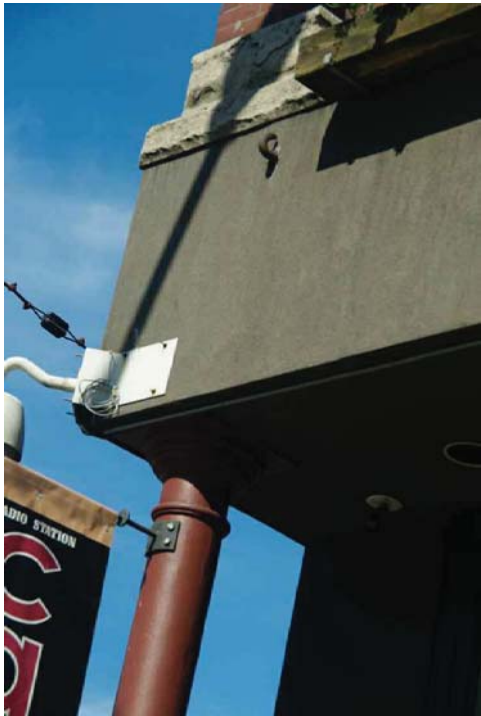
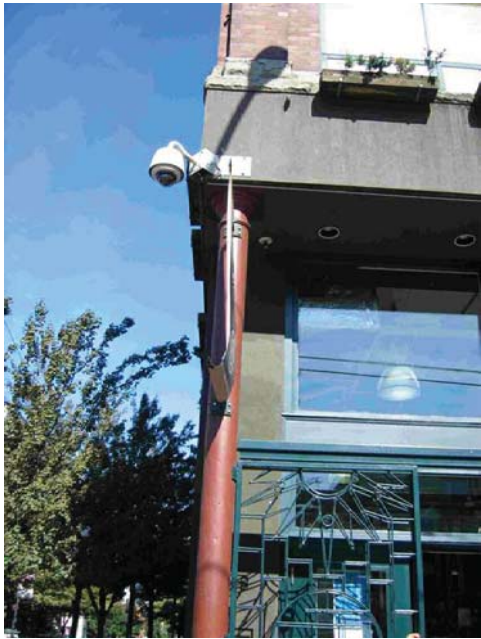
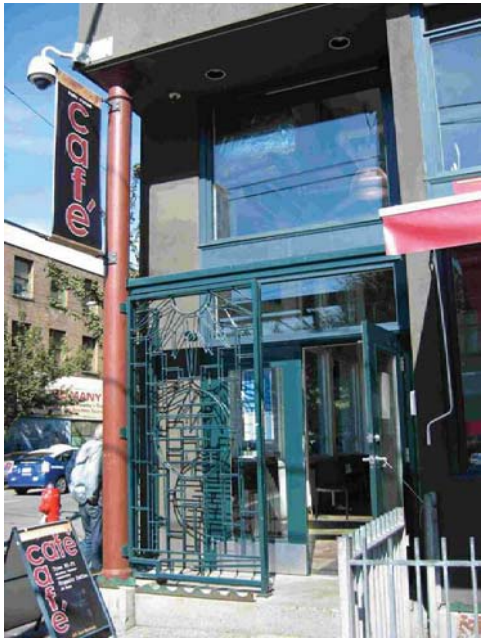
1 Existing South Elevation - Hastings Street
SCALE: $\frac{3}{16}'' = 1'-0''$

THE SLENDER DORIC STYLE CORNER COLUMNS WHICH ACCENTED THE INSET CORNER ENTRY ARE STILL EXPOSED. NO OTHER ELEMENTS OF THE ORIGINAL STOREFRONT HAVE SURVIVED.

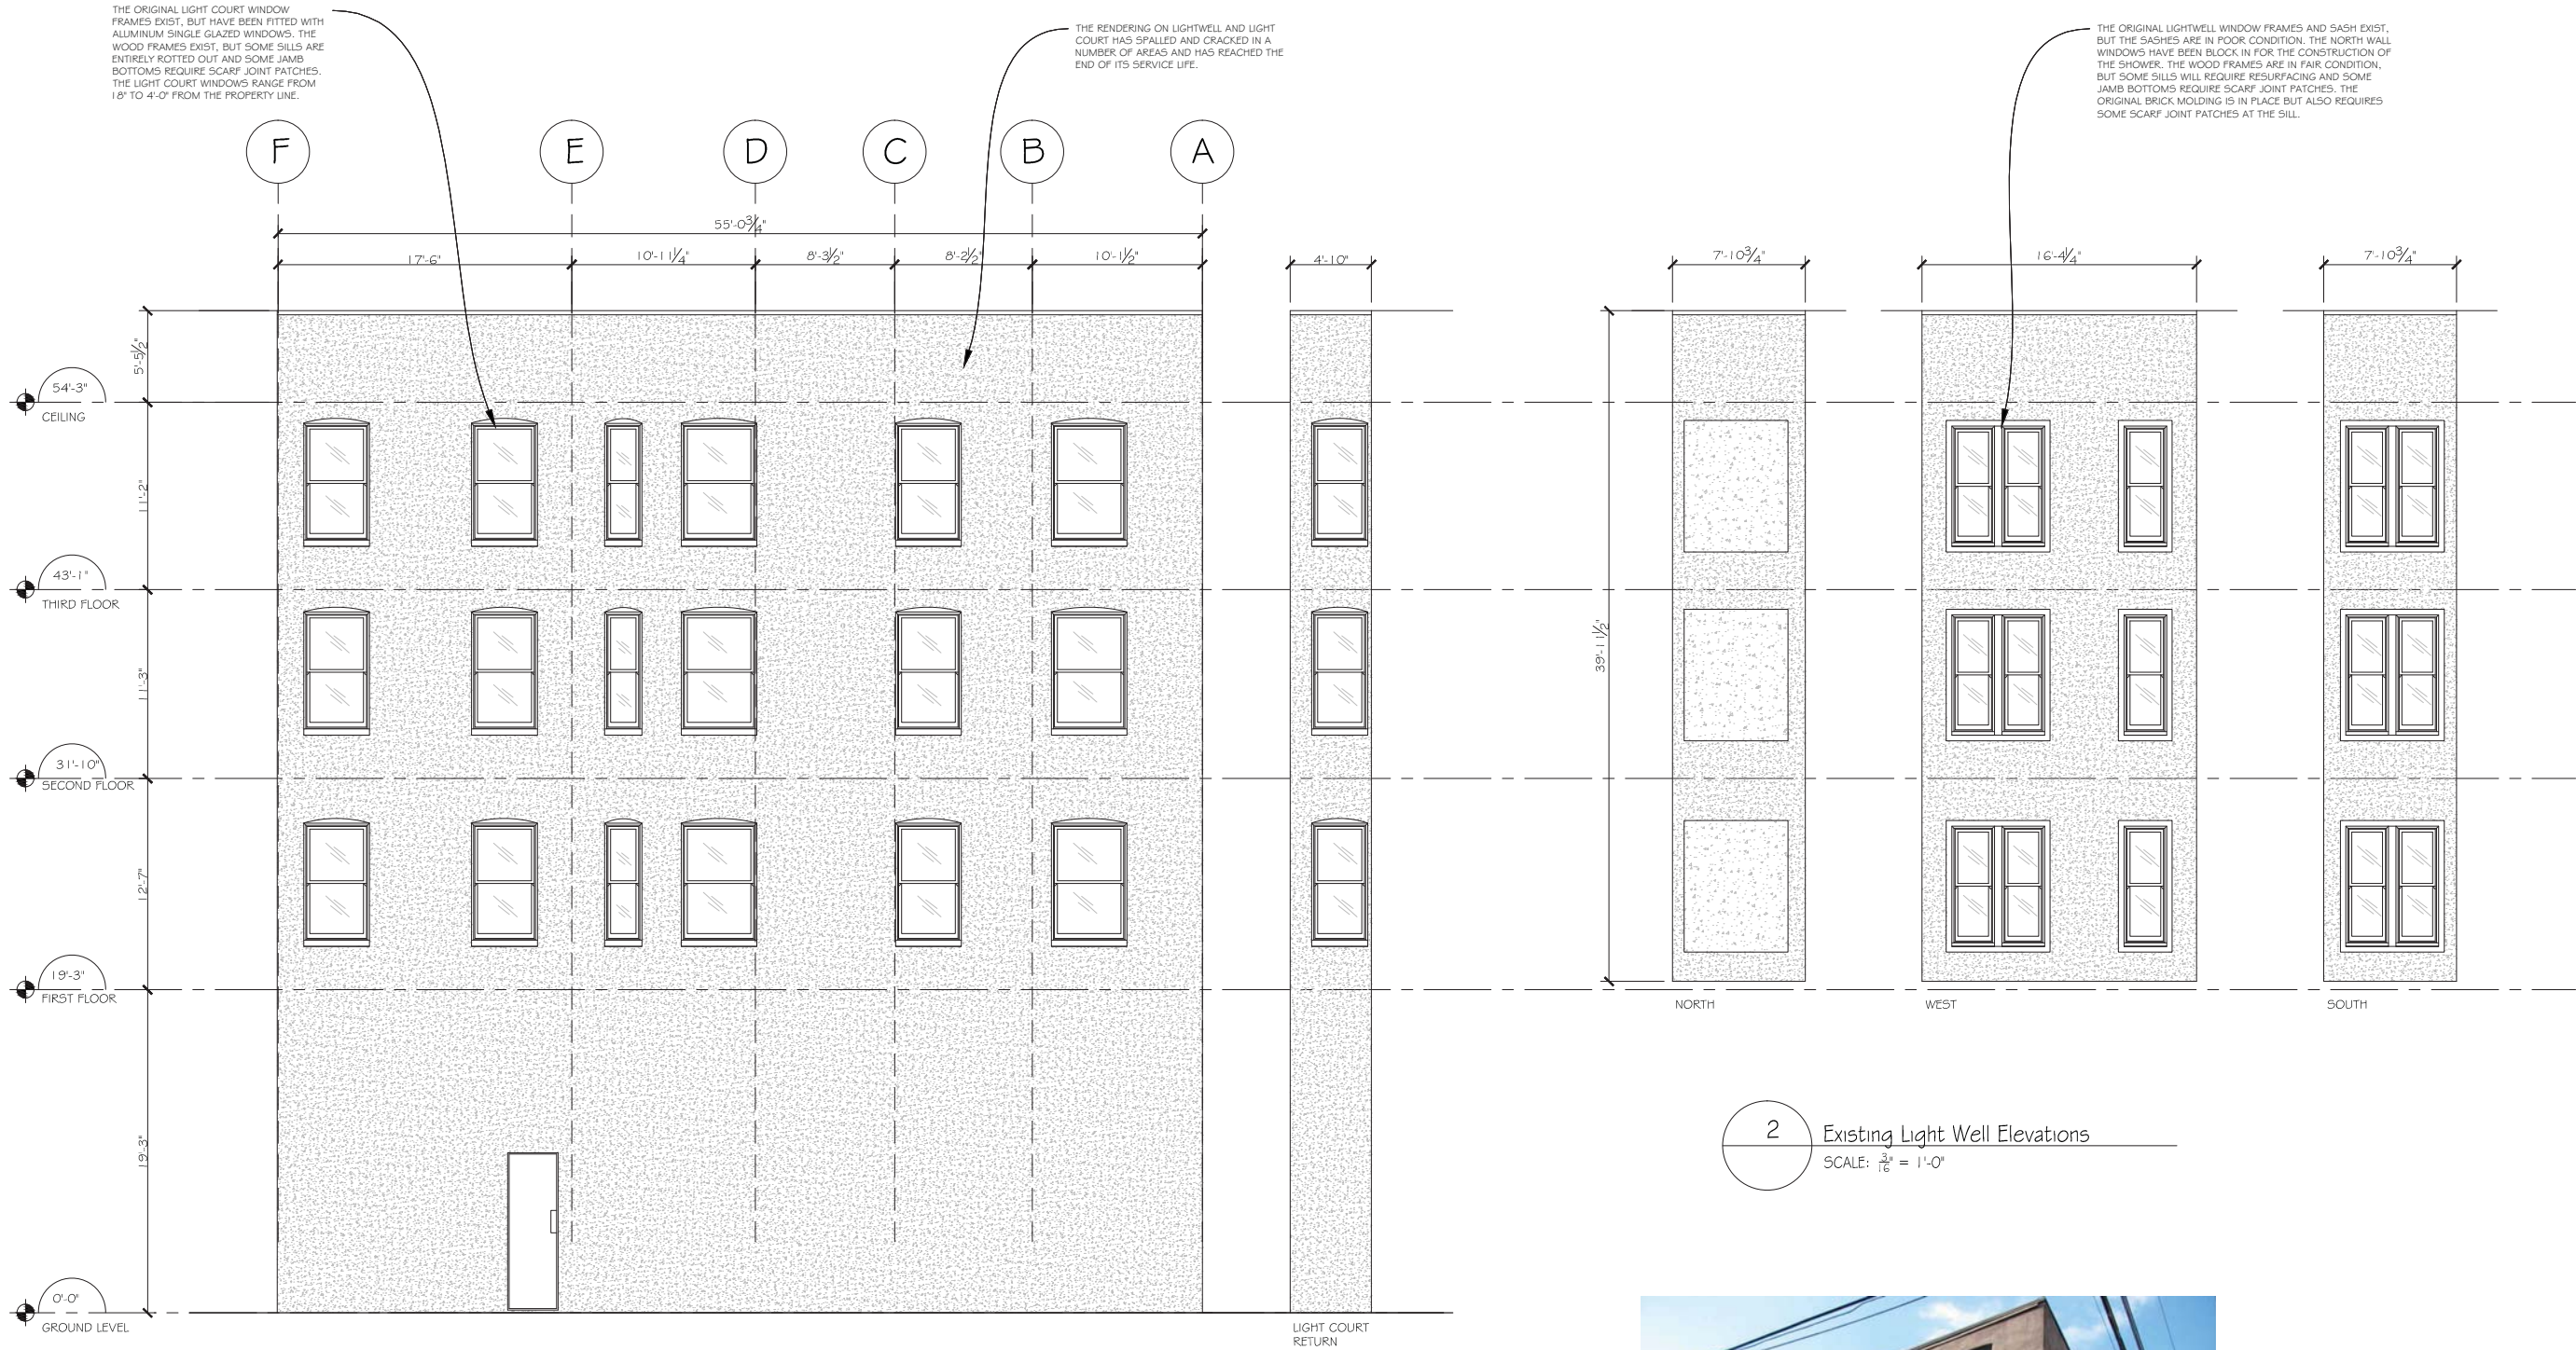
1 Existing Light Court Elevations
SCALE: $\frac{3}{16}" = 1'-0"$

The light well rendering is cracked and spalled and reached the end of its service life. This wall will be re-clad in new rainscreen metal cladding.

Light court and light well rendering has reached the end of its service life and will be replaced with a new rainscreen corrugated metal cladding system, with through-wall and header flashing systems.

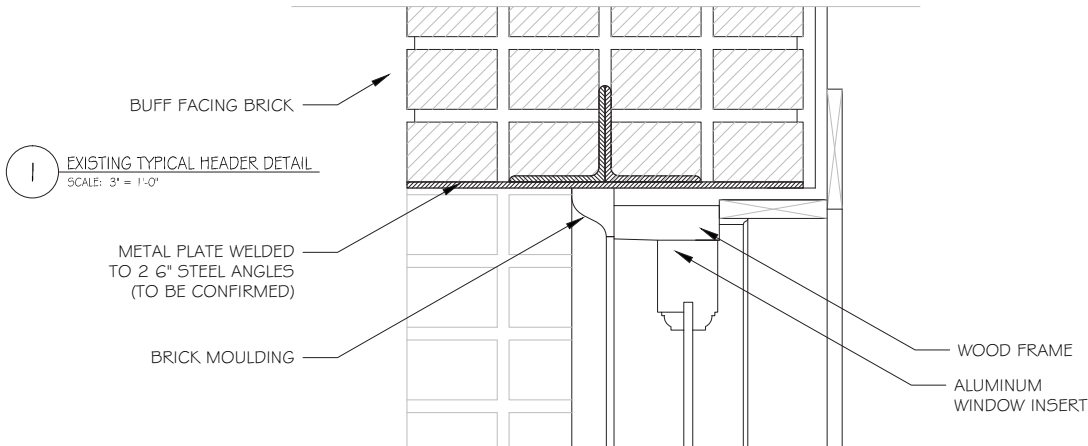
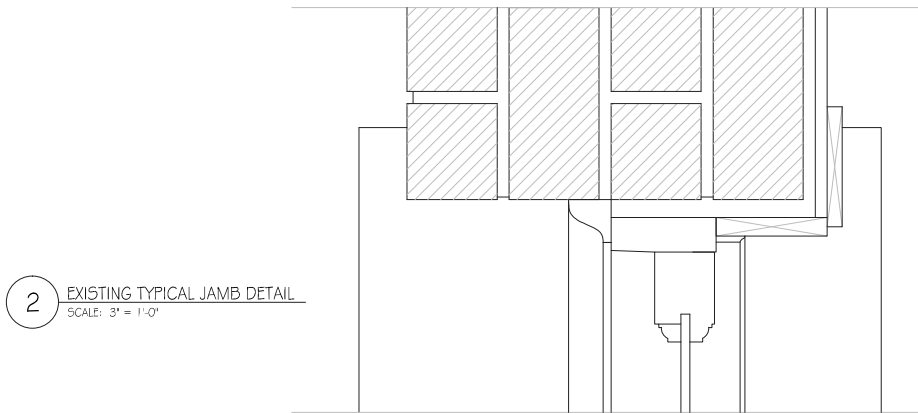
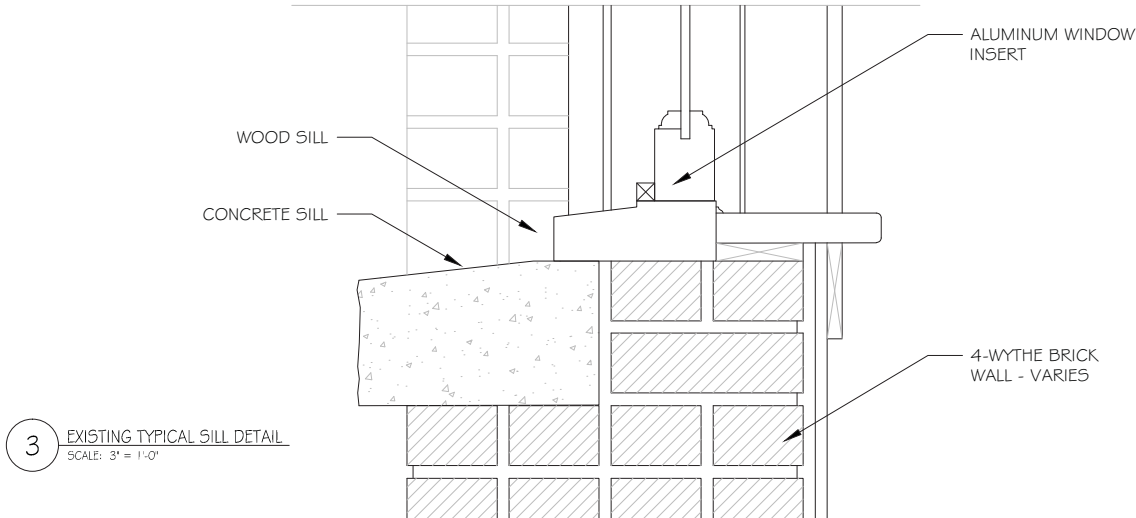
1 EXISTING WINDOW DETAILS
3" = 1'-0"

All of the third floor wood double hung windows are in place; the frames are in fair condition, but the sashes have reached the end of their service life. The existing frames, sills, and brick mold will be rehabilitated, with some sills requiring resurfacing for surface deterioration, some jambs and brick mold bottoms requiring scarf joint Dutchman patch repair. Provide new wood sash to the original profile, excepting slight molding profile variances, and fit with new sealed double glazed units, with a low E coating on surface 3, and fit with a Superseal glazing seal. Provide a wood stop on the inside of the sash, sealed with a bead of clear silicone sealant. Provide two lines of regletted pile weather stripping around the perimeter of each sash. Refurbish the weights, pulleys and cords for the new sash weight, refurbish existing cam closers and pulls, or provide new matching if the existing are missing or unserviceable.

New double glazed aluminum or metal clad windows approximating the original double hung configuration will be installed in the original refurbished wood frames. Allow for new wood sills to match the originals, which are deteriorated. Install new scarf-jointed jamb bottom patches and brick mold patches, as required.

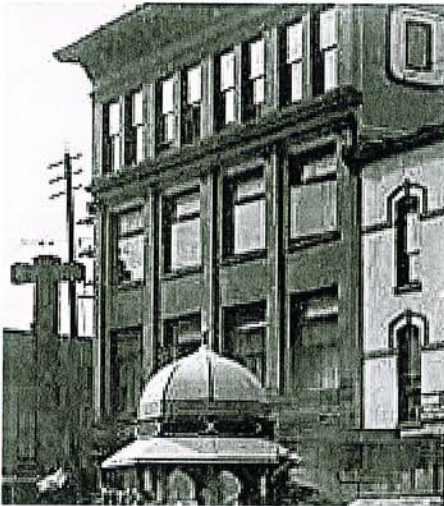
Front Façade Trim (Frames and Sash) – Top Paint Layer - Recommended Colour

Benjamin Moore
2050-10
Salamander
